Case study for assessing the integrity of a service-aged transformer repair using Frequency Response Analysis (FRA)

This paper describes the condition assessment of a 20-MVA power transformer based on frequency response measurements. The transformer under evaluation was removed from service and repaired in Rio Tinto workshop facilities after an internal water cooler leak and a thermal fault were detected. Before and after repair, FRA measurements were conducted to evaluate the integrity of the active part. The main results from these investigations are presented and discussed.

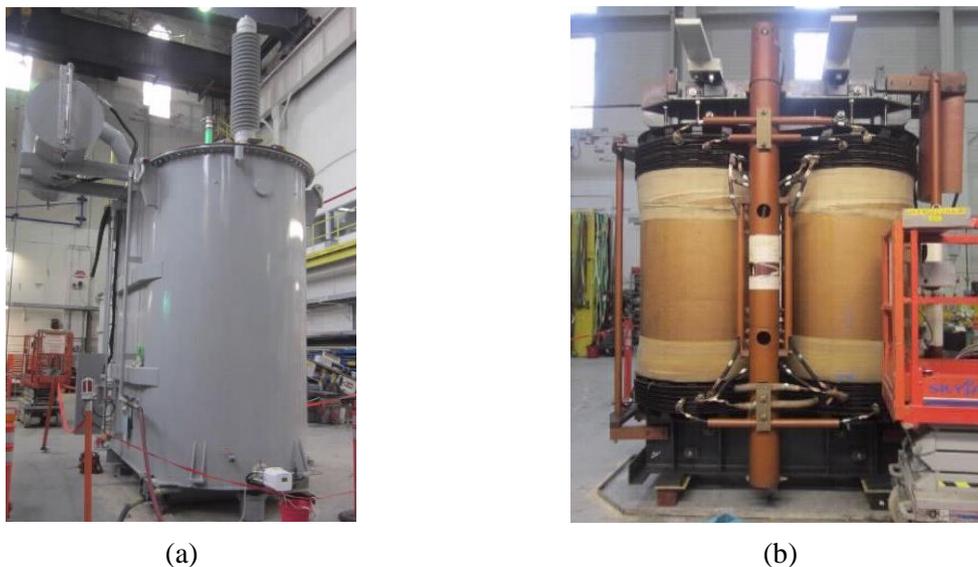
The transformer under evaluation, shown in Figure 1, is a single-phase unit rated 20 MVA, 161/13.2 kV manufactured by General Electric in 1951. The transformer is also composed of an off-load tap changer and an internal water-cooling system.

Figure 1: 20-MVA transformer (a) fully assembly and (b) out of the tank for inspection and repair.

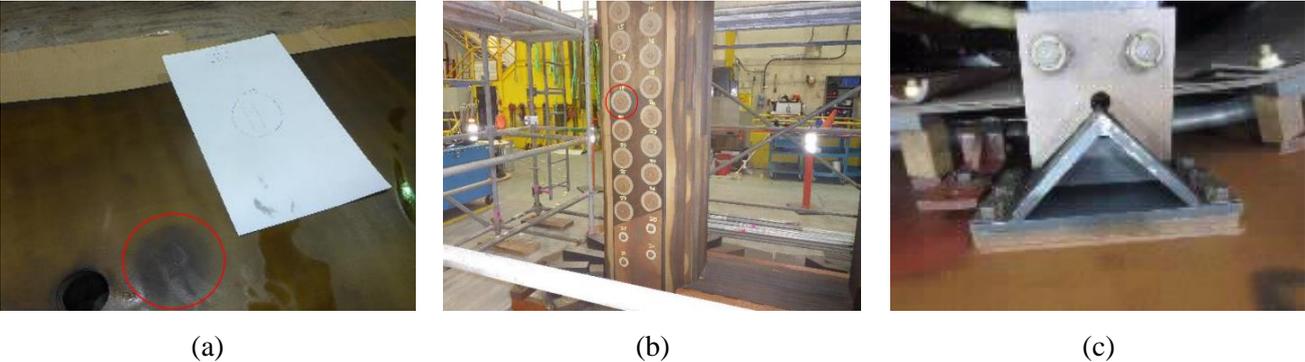
First, a FRA measurement was performed with the transformer active part out of the tank (Figure 1b). The windings were removed from the core and several insulation failures were identified during the visual inspection. The main failures identified are shown in Figure 2. The failures were then repaired, and the transformer was ready for reassembly. After reassembly, a new FRA measurement was taken to check for changes in the transformer subsequent to the disassembly, repair and reassembly.

Figure 2: Insulation failures (a) top yoke core sheets, (b) core clamp bolts, (c) metallic structure to tank.

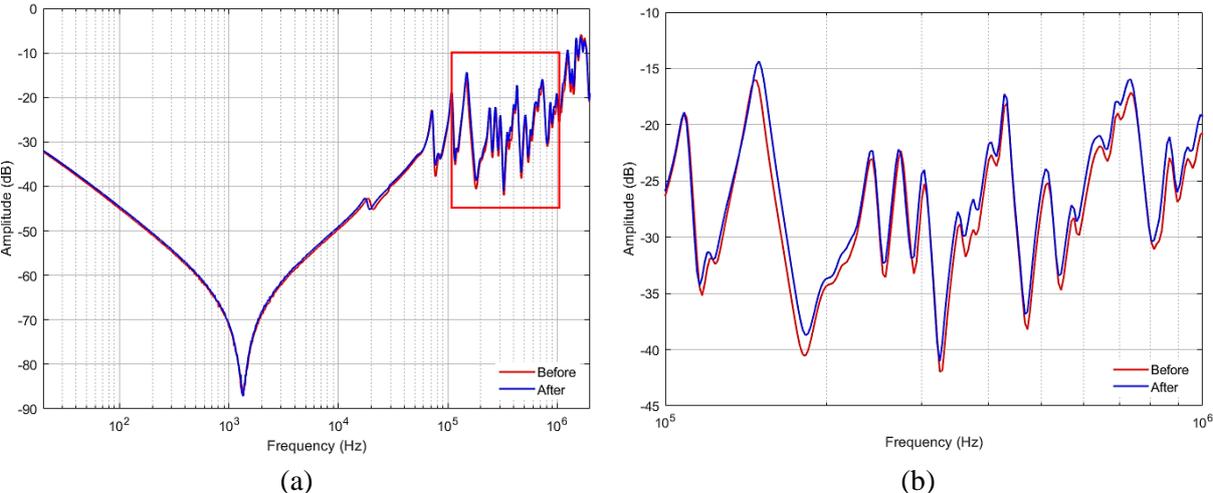
The zoomed-in 100 kHz to 1 MHz portions of the graphs in Figures 3 and 4 show considerable deviations between traces. Since there was no change in winding resistance or inductance, it can be assumed that the series and/or parallel capacitances changed to justify the deviations.

After investigating the possible changes in the insulation capacitances, the capacitances from winding to ground were identified as the main cause for deviation in the traces. In fact, when the core was repaired, the connections between core and ground were modified (see Figure 5). In the previous connection scheme (Figure 5a), the lower end frame was electrically connected to the core, which was connected to the upper end frame, and then the structure was grounded. After repairs (Figure 5b), the lower and upper end frames were independently connected and then grounded, and the core was grounded separately. Both ground connections were made through a small bushing located in the transformer cover.

It was also apparent that the clamping pressure was not the same for both measurements. For the first measurement, before disassembly, the winding clamping pressure was the same as in operation. However, for the second measurement, after reassembly, clamping pressure was not applied. As discussed in [9], a change in clamping pressure can influence the magnitude of resonance peaks without changing their frequency, as noted on Figures 3 and 4.

Figure 3: Frequency response traces for 20 MVA HV end-to-end open circuit measurement (a) complete frequency range and (b) zoomed portion.

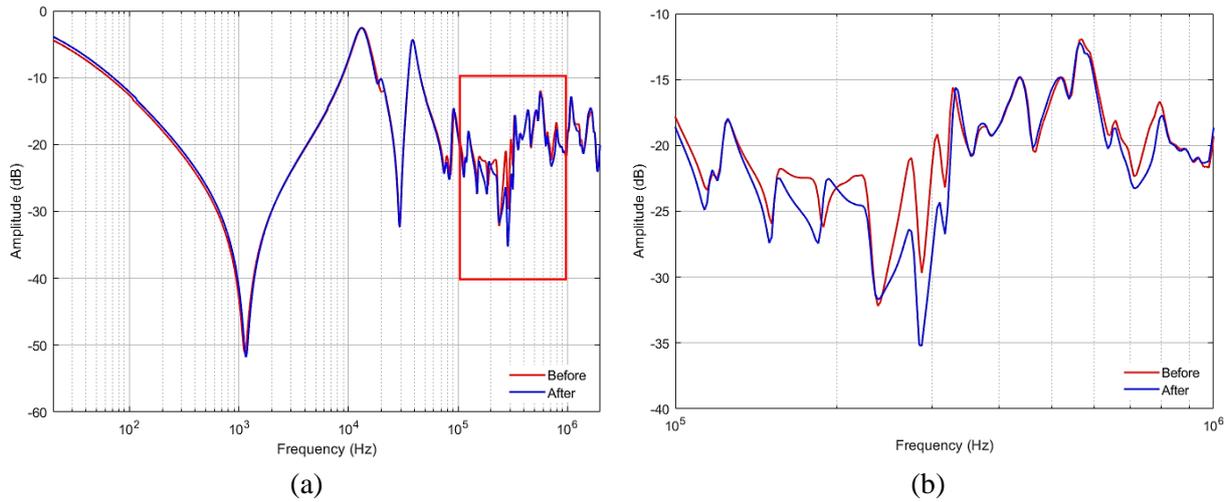
Figure 4: Frequency response traces for 20-MVA LV end-to-end open circuit measurement (a) complete frequency range and (b) zoomed portion.

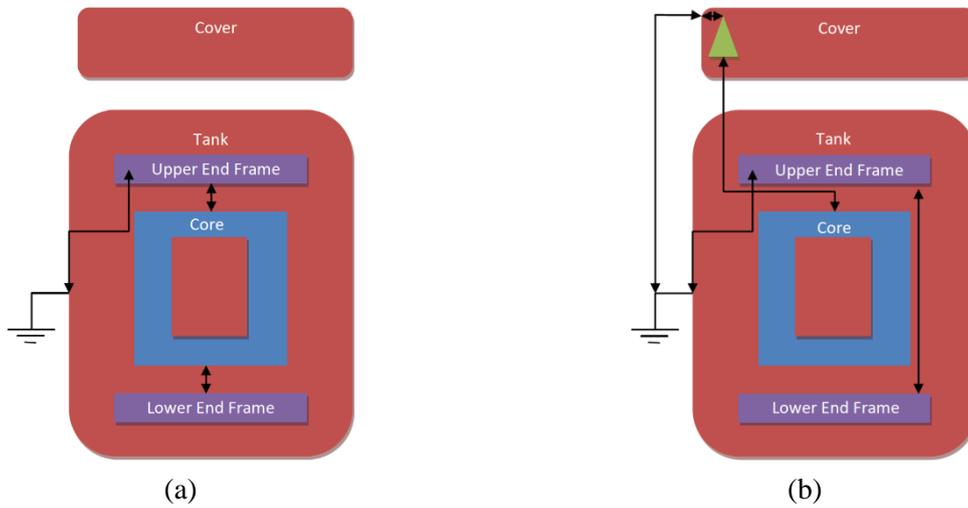
Figure 5: Core to ground connection (a) before repair and (b) after repair.

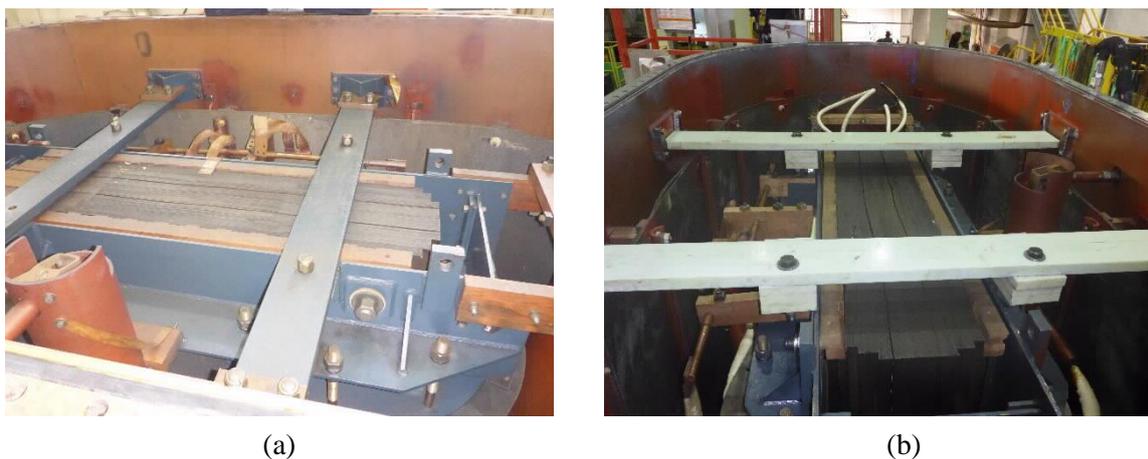
Another change to the transformer structure is shown in Figure 6. The structure connecting the upper end frame to the tank was modified, replacing the previous (Figure 6a) metallic structure with a composite one (Figure 6b).

Figure 6: Upper end frame structure connection to tank (a) before repair (metallic connection) and (b) after repair (composite connection).

The modifications in the core-to-ground connection, along with the changes in the connecting frame and tank structures, may influence the earth capacitances of the windings. Evidence of these changes were shown in FRA measurements of both the high voltage and low voltage windings.

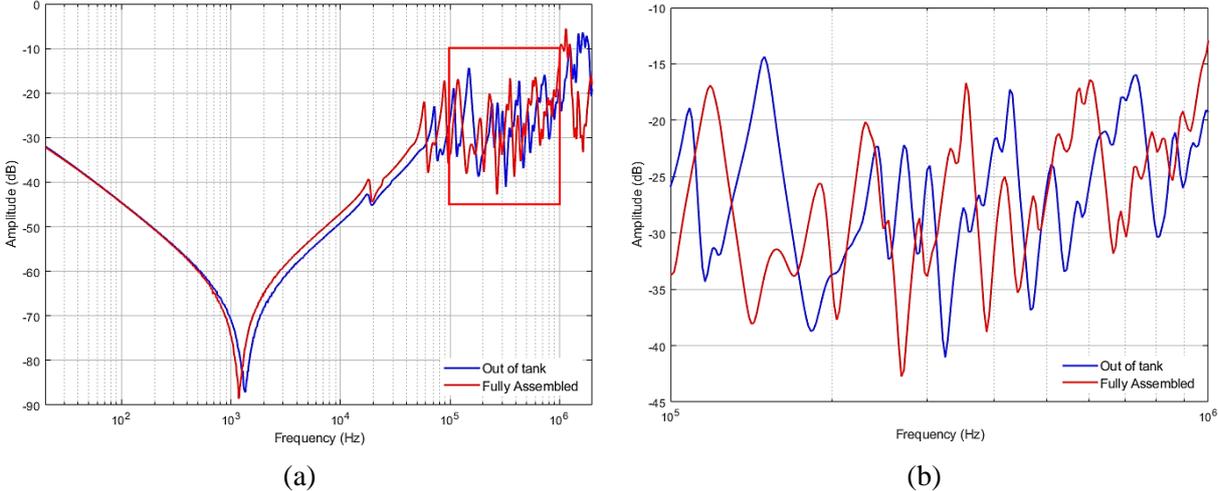
Furthermore, the transformer was fully assembled and a comparison of post-repair measurements, one with the active part out of the tank and the other with the transformer fully reassembled, is shown in Figures 7 and 8. From this example, it is possible to identify the influences of the insulating oil, tank and bushings in the measurements. The presence of oil has a considerable effect on the permittivity of the medium, reducing the resonance frequencies and shifting the entire curve to the left [5]. In addition, other capacitive effects such as the presence of the tank and bushings may affect the frequency response in different ways. Consequently, other deviations can be found in Figures 7 and 8, such as a reduction in resonance amplitude, new resonances and an absence of resonances.

Figure 7: Frequency response traces for 20 MVA HV end-to-end open circuit measurement out of the tank and fully assembled (a) complete frequency range and (b) zoomed portion.

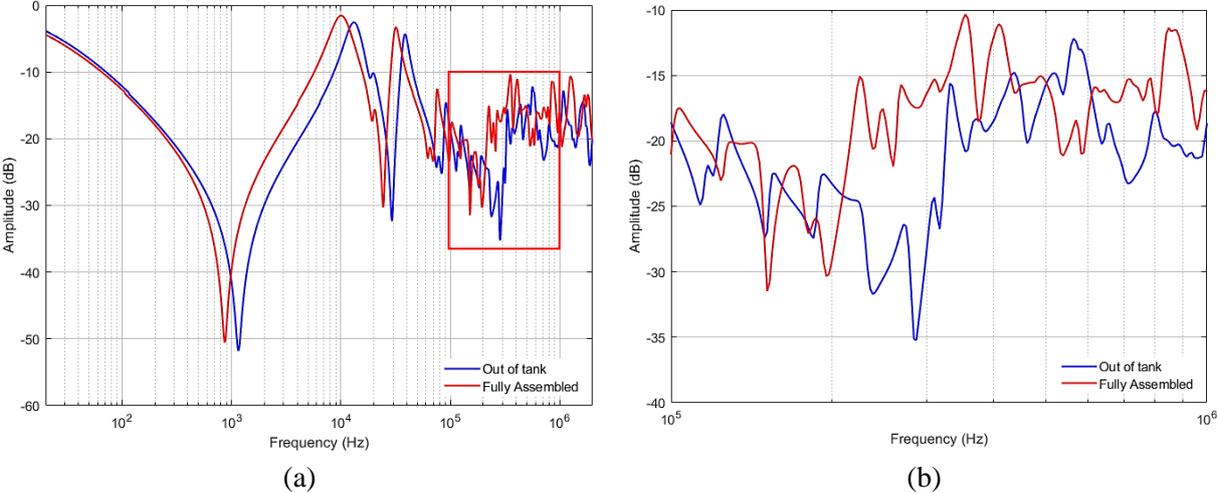
Figure 8: Frequency response traces for 20-MVA LV end-to-end open circuit measurement out of the tank and fully assembled (a) complete frequency range and (b) zoomed portion.

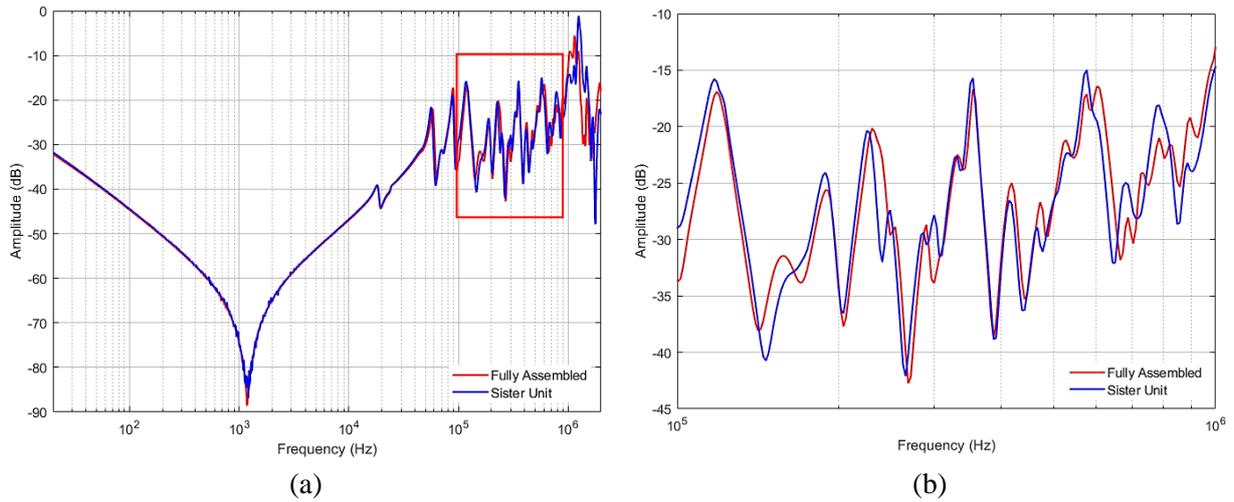
The post-repair traces for the fully assembled transformer were also compared with a sister unit installed in the same substation. Both traces are shown in Figures 9 and 10. For the sister unit comparison, the acceptable deviations are higher. Despite having the same characteristics (e.g. technical specifications, year of manufacture and consecutive serial numbers), manufacturing tolerances result in slight deviations. Therefore, the traces shown in Figures 9 and 10 can be considered a good match. However, it is important to consider that the sister unit has not been submitted to the same repairs and modifications as the transformer under evaluation. This can also explain the deviations beyond the manufacturing tolerances found in the traces.

Figure 9: Frequency response traces for 20-MVA HV end-to-end open circuit measurement and sister unit (a) complete frequency range and (b) zoomed section.

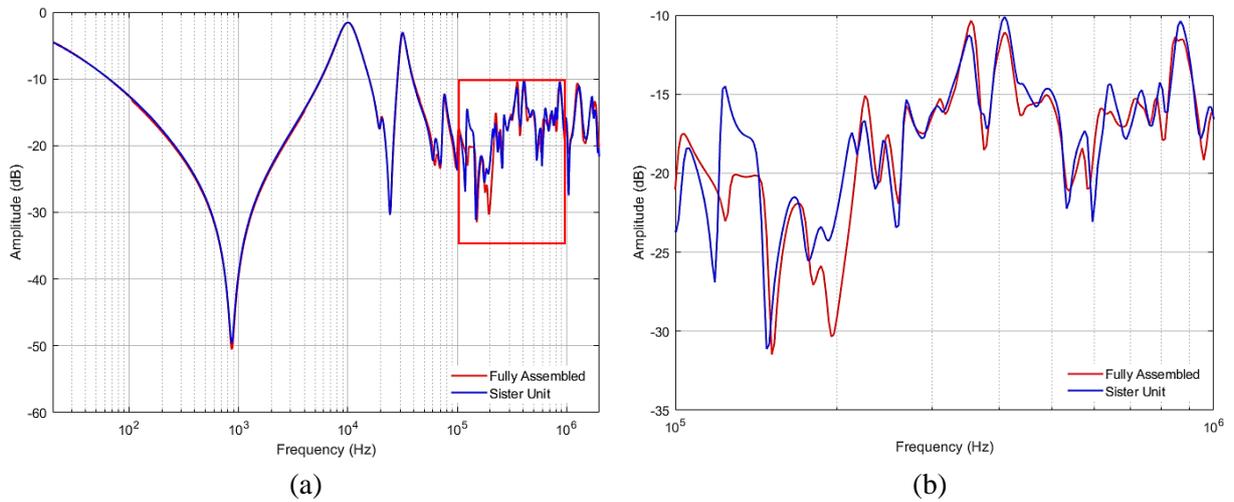
Figure 10: Frequency response traces for 20-MVA LV end-to-end open circuit measurement and sister unit (a) complete frequency range and (b) zoomed section.
