## Electrical Tests on Fire Retardant Contaminated Cap and Pin Insulators

**C. BONILLA**  
**Powertech Labs. Inc.**  
**Canada**

### SUMMARY

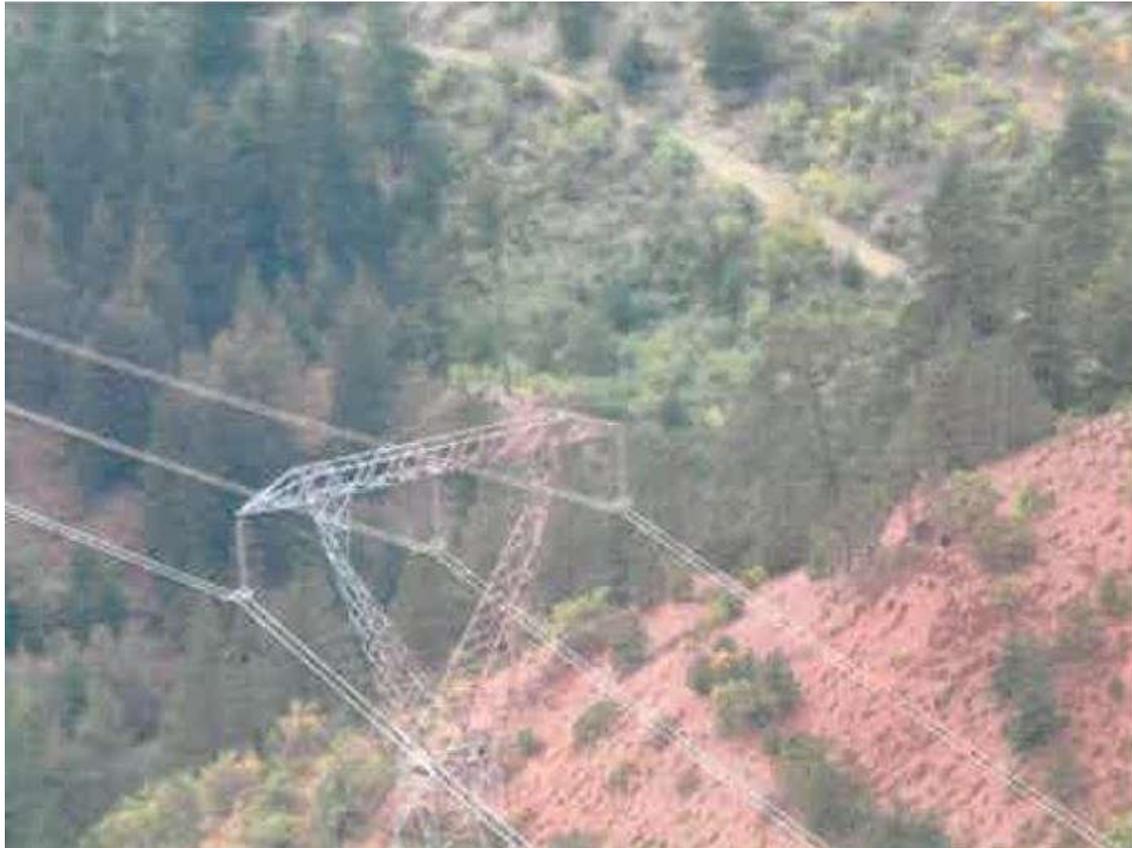
Porcelain suspension insulators of one transmission line and toughened glass suspension insulators of the parallel transmission line were contaminated with fire retardant residue. The fire retardant contaminated the top and bottom shell of both porcelain and toughened glass suspension insulators. Figure 1 and Figure 2 show the fire retardant contamination on lattice tower and transmission line hardware, respectively.

**Figure 1.** Fire Retardant on Steel Tower.

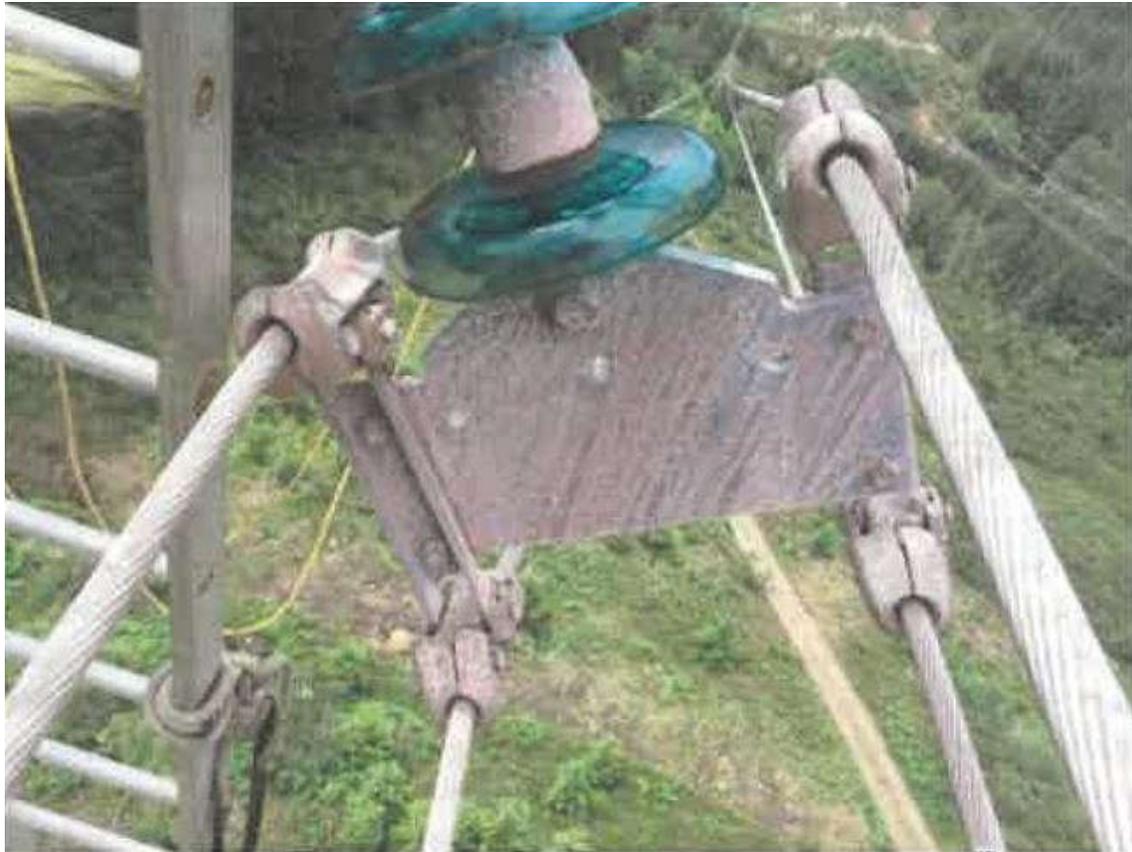
**Figure 2.** Fire Retardant on Transmission Line Hardware.

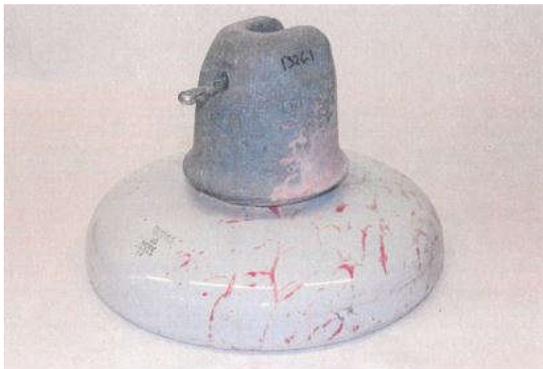
**Figure 3.**  
Fire Retardant Residue on Top Porcelain.

The visual inspection of the selected twelve porcelain and glass suspension insulators shows that they had some fire retardant residue. There was no flashover damage, no radial cracking, no loss of filling and no corrosion. The overall insulators' condition rating equals 3 – Moderate defects and damages.

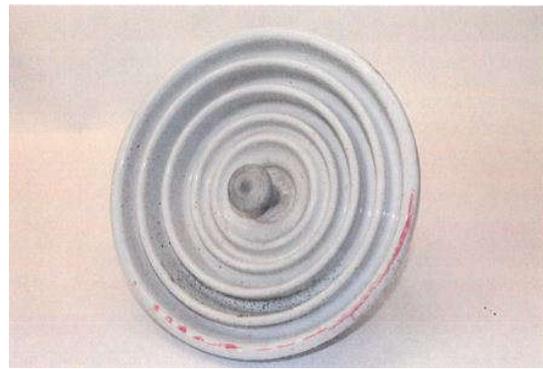
**Figure 4.**  
Fire Retardant Residue on Bottom Porcelain.

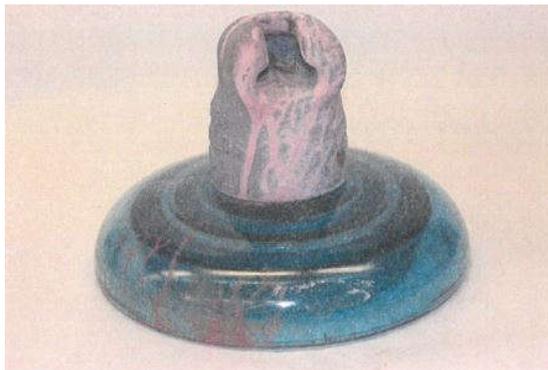
**Figure 5.**  
Fire Retardant Residue on Top Glass.

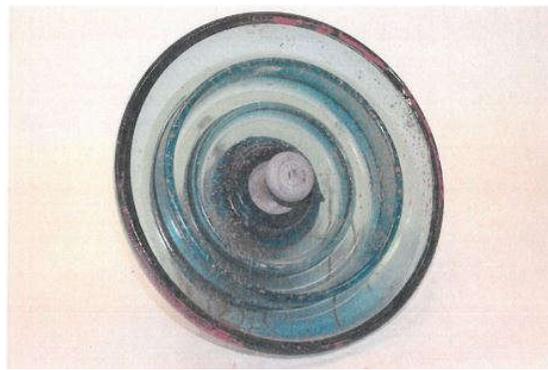
**Figure 6.**  
Fire Retardant Residue on Bottom Glass.
