Root cause analysis of damaged ACSR conductors during construction of a 500 kV transmission line

**Chen Wang and Roberta Radons
Manitoba Hydro
Canada**

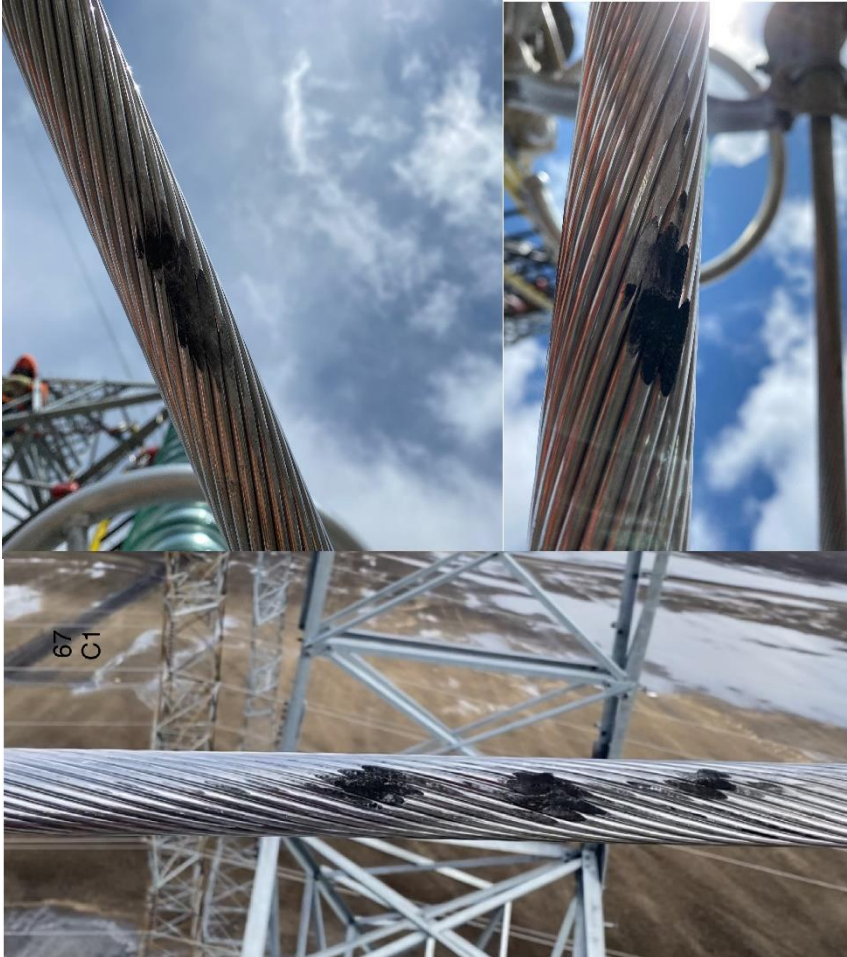
Figure 1, Examples of Damaged Locations on Phase Conductor

During the routine construction inspection, the field inspectors identified several “black marks” along the phase conductor in random locations near the suspension clamp, which was flagged by quality control and resulted in a quality nonconformance report being submitted to the Line Design group. To facilitate confirmation of the damage, a crew was sent to examine the damage at a close distance. Figure 1 shows examples of sections of damaged phase conductor along the line.

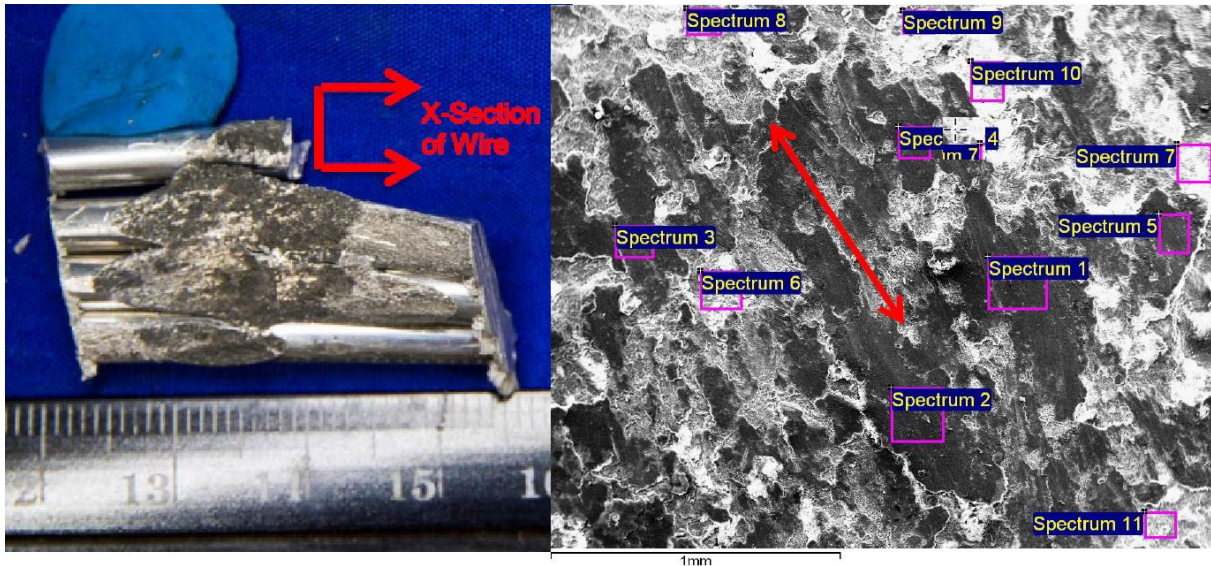
Figure 2, Scanning Electron Microscope (SEM) Micrograph

The sample of damaged conductor was also sent to a chemical lab for future analysis. A portion of the outer surface of the conductor containing wire strands was cut out for the Scanning Electron Microscope (SEM) examination / Energy Dispersive X-Ray (EDX) Chemical Analysis of the damaged surface of the conductor. The SEM view of the "black mark" is shown in Figure 2.

SEM micrograph showing the interface between the “shiny” aluminum wire and the “black mark” damage. An energy dispersive X-Ray chemical analysis (using the scanning electron microscope / SEM) was used to determine the chemical difference between the 2 different areas on the wire strand as defined by Spectrum #1 (shiny aluminum) and Spectrum #2 (“black mark”). Based on the chemical analysis, the “black mark” on the phase conductor is aluminum oxide which could be caused by local frictional heating.

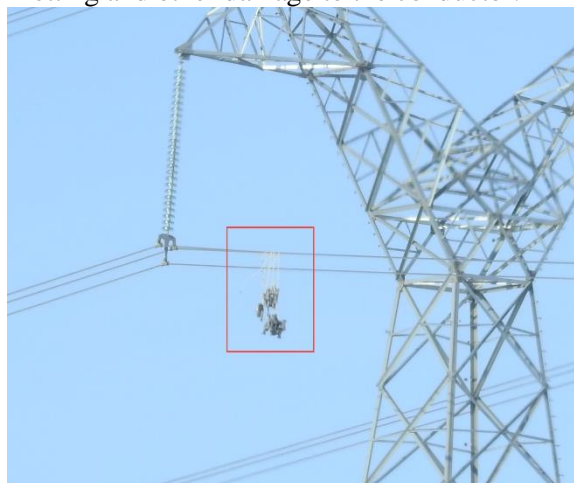
Figure 3, Improper Hanging the Spacer-Damper on the Conductor

During the inspection, some spacer-dampers were left hanging on the phase conductor as shown in Figure 3. The weight of the spacer dampers at the attachment point on the conductor would create another vibration node, subjecting the conductor to severe bending amplitudes due to aeolian vibration. This bending may result in fretting and other damage to the conductor.

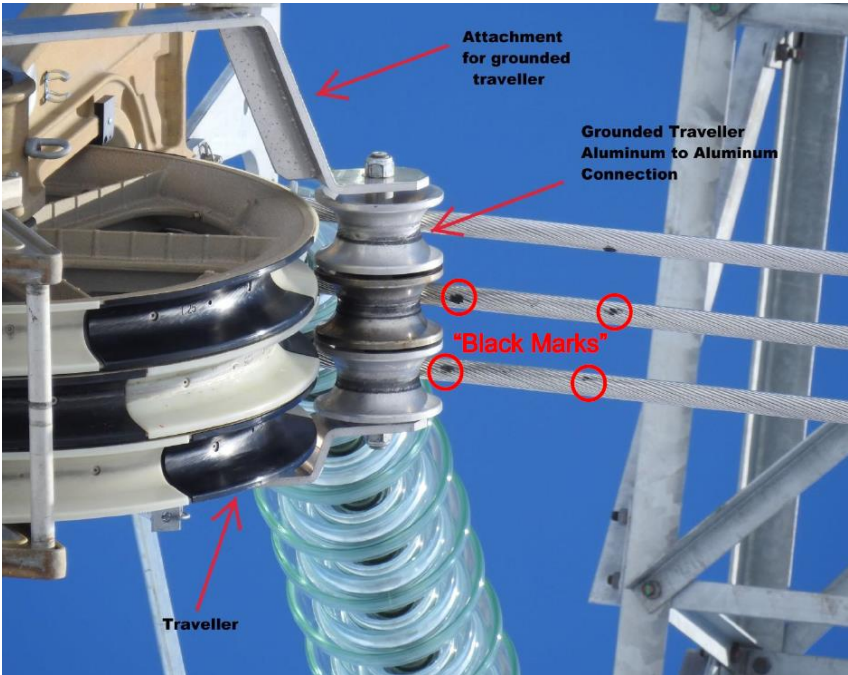
Figure 4, Typical Installation of Ground Traveler

The ground traveler was also identified as contributing to the conductor damage. The ground traveler is made of aluminum alloy and ductile iron. As the outer layer of ACSR conductor is made of pure aluminum which is relatively soft compared to ductile iron or aluminum alloy, it is feasible that conductor resting on the ground travelers could deform due to the weight of the conductor, and/or be eroded by friction (and accompanying heat) damage induced by aeolian

vibration. The documented delays based on construction records in stringing that allowed the conductors to sit on the ground traveler for a long period are also considered to have caused damage on the conductor surface. The installation of ground traveler is shown in Figure 4.

The stringing procedure including the ground traveler application has been revised at Manitoba Hydro to minimize the possible conductor damage in future project. Manitoba Hydro's experience has been also shared within IEEE standard 524 committee (IEEE Guide for the Installation of Overhead Transmission Line Conductors) for consideration in future updates to their standard.

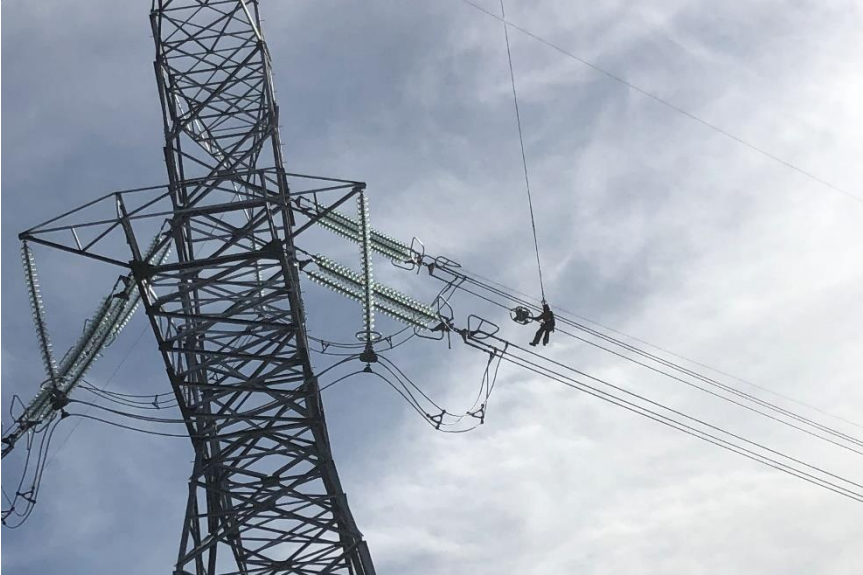
Figure 5, Typical Installation of LineVue Tool

A field inspection of damaged conductor identified damage on its outer layers but could not confirm if the steel core's condition was undamaged. To acquire the knowledge of the actual physical condition of the conductor's steel core, the LineVue inspection tool made by Kinectrics was used for this project. The LineVue device is a field-based, non-destructive inspection system that "looks through" the aluminum wires and into the steel core wires. Its function is to measure the remaining cross-sectional area of steel wires and to detect any localized breaks or corrosion pits. The inspections can be performed on de-energized and energized conductors up to 500 kV. Figure 5 shows the installation of LineVue tool on the conductor. Based on the performed LineVue inspections on all identified damaged locations, no damage was found on the steel core at the inspected locations.

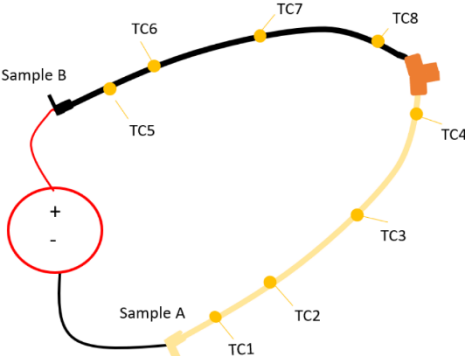
Figure 6, Thermal Performance Test Setup

In addition to mechanical strength loss, a degradation in electrical/thermal performance was also a concern and was investigated in a 3rd party lab. Two (approximately) 16-foot sections of conductor with significant abrasions were removed from the line. These two sections were placed in series within an AC circuit to test their thermal performance. Thermocouples were placed approximately 7 inches from the bolt-on NEMA pad connectors used to electrically connect the samples and the power supply. Additionally, a thermocouple was placed on the damaged portion of the conductor and a healthy portion of the conductor. The circuit was loaded with 1200 amps AC, the ambient temperature was 22.4°C. Under these conditions, Sample B operated at a significantly higher temperature where the abrasion was located (TC 6). The expected operating temperature for this conductor under these conditions was 94°C; the test results summarized in Table 2 that some damage resulted in localized heating that exceeded the design temperature and may cause annealing of the conductor.
