Analysis of Directional Protection on distribution feeders for DER interconnection and its performance during Multi-Fault Events

Marco Ciofani, Iraj Rahimi, Harjinder Sidhu
AltaLink Management Ltd.

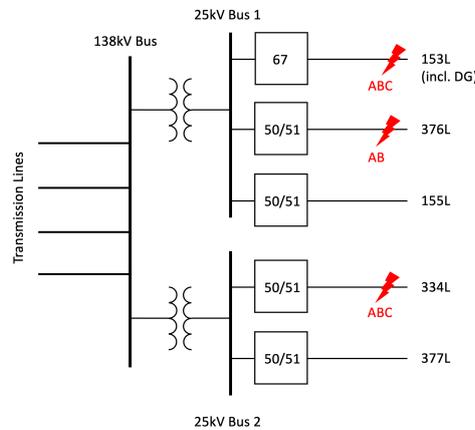
Figure 3 - Substation Configuration

Figure 3 shows the configuration of the substation under consideration. There are five feeders supplied by two 138/25kV transformers. Only one feeder, designated 153L, includes a connected DER.

The event under study started with a suspected lightning strike that led to the development of a three phase fault simultaneously on 153L and 334L, which are double circuited on the distribution poles. After approximately 140ms (8.4 cycles) an A-B fault also developed on 376L. The exact mechanism by which this second fault occurred is not known, however this line is also double circuited with 153L close to the suspected location of the incipient fault.

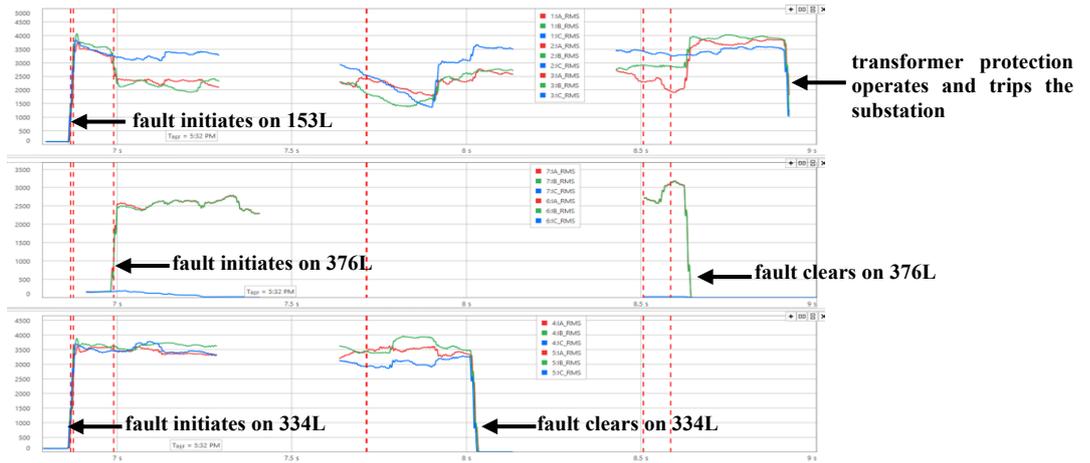
Figure 4 – RMS Currents on 153L, 376L, and 334L (top to bottom)

The non-directional time overcurrent relays for 334L and 376L tripped their respective feeder breakers as designed in approximately 1.17 and 1.65 seconds respectively. However, the directional equipped 153L relay failed to issue a trip to clear the fault, and as a result the substation transformer overcurrent protection operated as backup after 2.06 seconds. This caused the entire substation to trip off (the transformer does not have a high side breaker) and created significant customer interruptions. This behavior was initially considered contrary to expectations, as the forward fault current on 153L was more than adequate to operate the overcurrent element in a similar timeframe as the other two feeders. The various feeder currents recorded by their respective relays are shown in Figure 4.

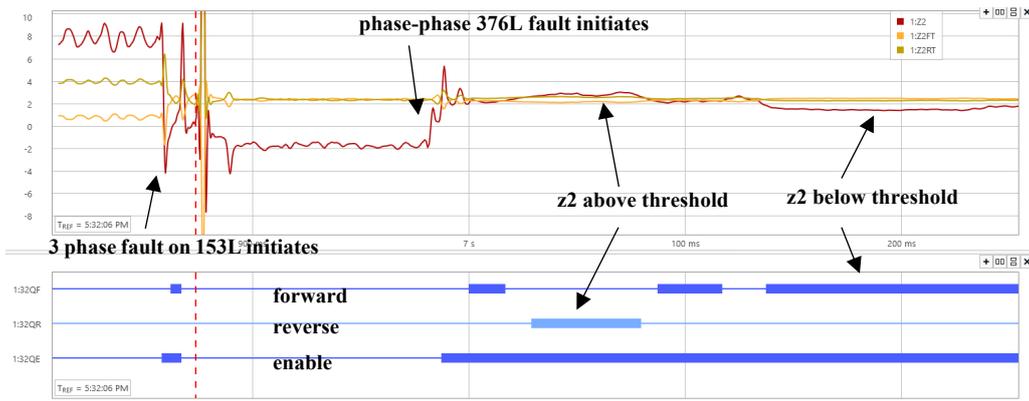
Figure 5 – 153L relay directional declarations during the initial period of the fault

Upon examination of the relay records, it was observed that the 153L relay saw enough negative sequence current to enable the directional element after the fault on 376L initiated, however the directional declarations began to cycle repeatedly between forward and reverse. This condition lasted until the fault on 376L had cleared, at which point the 153L directional element dropped out and the overcurrent element began its cycle. By this point it was too late for the relay to complete its cycle before the transformer protection backed it up and tripped the substation.

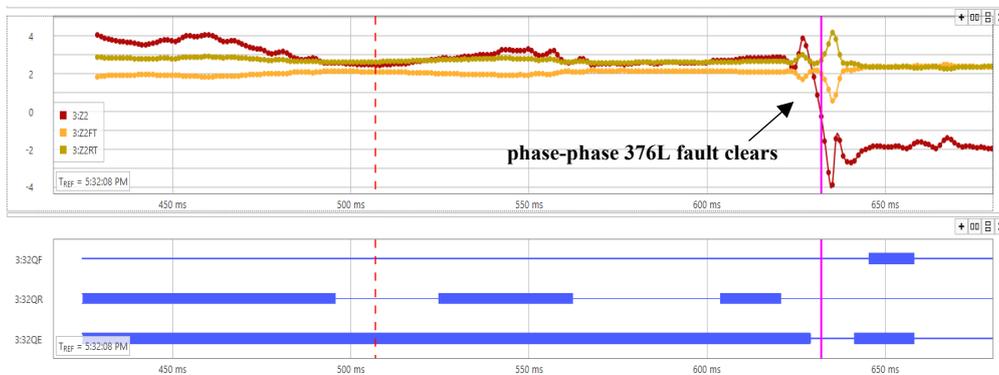
Figure 6 - 153L relay directional declarations during the latter period of the fault

The measured and calculated quantities show generally good agreement. The important point is that the operating quantity z_2 falls close to or in between the threshold quantities. Since these thresholds are quite close together, and the z_2 quantity would have been fluctuating over the course of the fault, it is unsurprising that z_2 crossed above and below the thresholds as the fault progressed, rendering the relay incapable of making a determination as to the fault direction.

The fact that z_2 happened to be close to the threshold quantities is a consequence of the location of the fault on 153L. The z_2 value seen by the relay was equivalent to the line impedance between the substation and the 153L fault location, which happened to be about halfway down the line. Since the threshold setting is equal to half the line impedance, this meant that the operating quantity developed a similar value to the threshold settings. Had it been a close-in fault, then the z_2 quantity would have been close to zero and the relay would have declared a forward fault. Had it been close to the end of the line then the impedance would have been higher, and it would have declared a reverse fault. Incidentally, the reverse declaration is more “correct” in this case, as the source of negative sequence current is in the reverse direction (on 376L). Notwithstanding the fact that a forward declaration would have been more desirable in this case, the calculations show that the 153L relay behaved as expected given the conditions, and therefore this was not considered a mis-operation.

One possible mitigation would be to increase the bias of the forward threshold Z2F. For this event, a higher Z2F value would have caused the z2 operating quantity to fall within the forward zone and issue a trip. However, making this change would also increase the risk that the line would trip for external faults. As the thresholds are increased, the margin between the reverse threshold and the expected impedance for a reverse fault condition is reduced, which in turn reduces the security. Considering that an individual external fault occurs much more frequently than any simultaneous fault, this would seem to be a poor trade-off of security for dependability.

Another option would be to connect the feeder relays together and incorporate logic such that each relay is made aware of fault conditions on its neighbors and be able to respond accordingly. This would require additional wiring and logic but could be viable if the need arose.
