CIGRE-479

Root cause analysis of damaged ACSR conductors during construction of a 500 kV transmission line

Presented by: Chen Wang
Senior Transmission Engineer
Manitoba Hydro

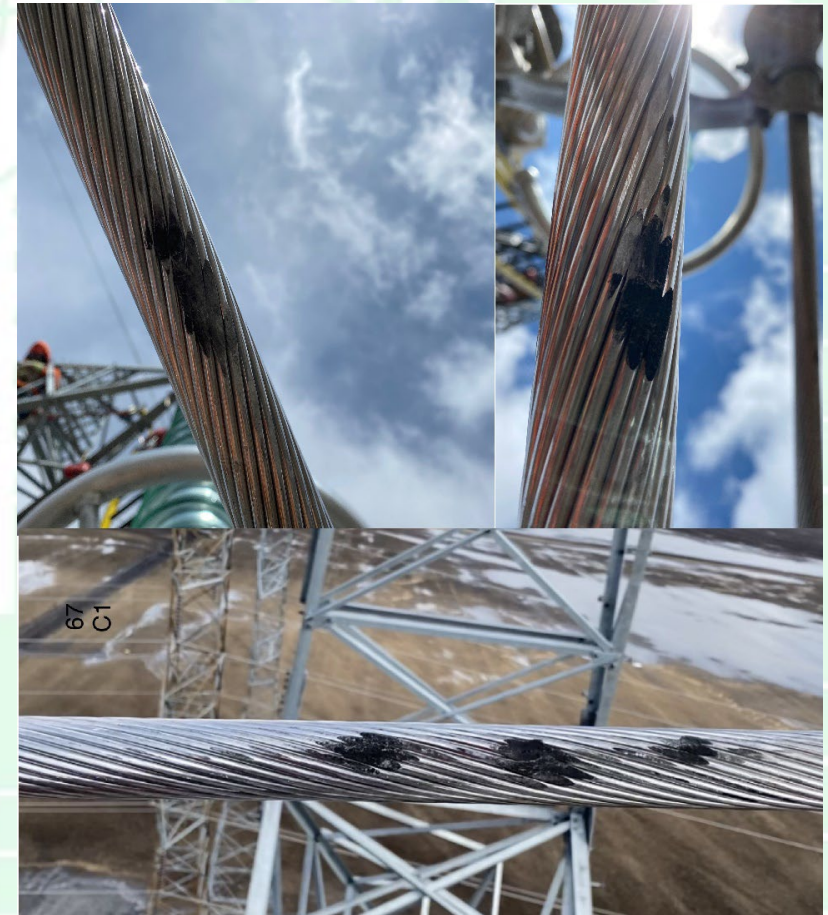
- After the conductor stringing, our field line inspectors identified multiple damaged locations and “black marks” along the phase conductor near the suspension clamp.
- Some locations experienced severe damage such as broken strands and some other locations have flattened wires or cut marks.
- These unanticipated damages raised a major concern on the lifespan of the conductor and required a detailed investigation and root cause analysis.

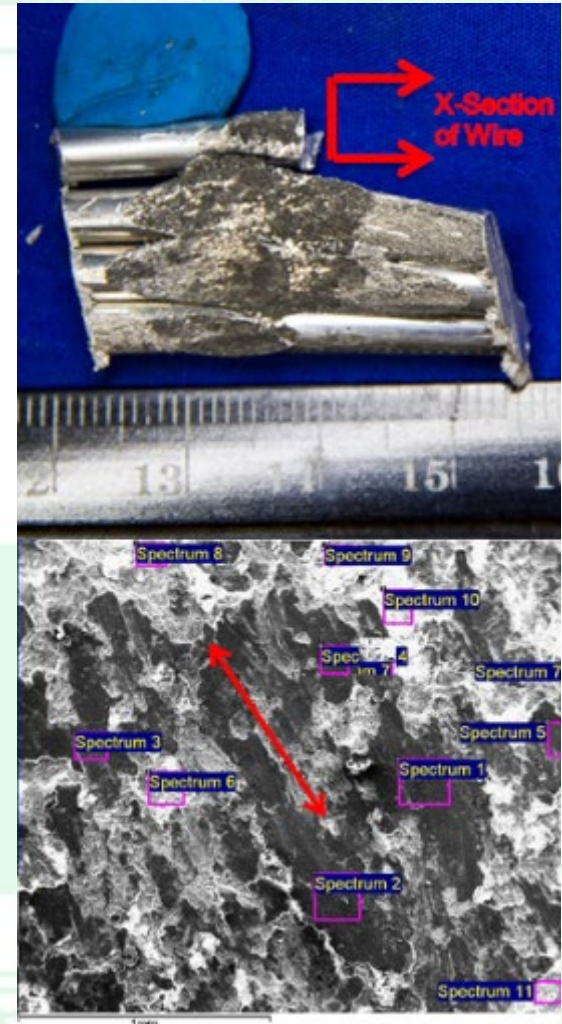
- The sample of damaged conductor was also sent to a chemical lab for further analysis.
- A portion of the outer surface of the conductor containing wire strands was cut out for the Scanning Electron Microscope (SEM) examination / Energy Dispersive X-Ray (EDX) Chemical Analysis of the damaged surface of the conductor.
- Based on the chemical analysis, the “black mark” on the phase conductor is aluminum oxide which could be caused by local frictional heating.

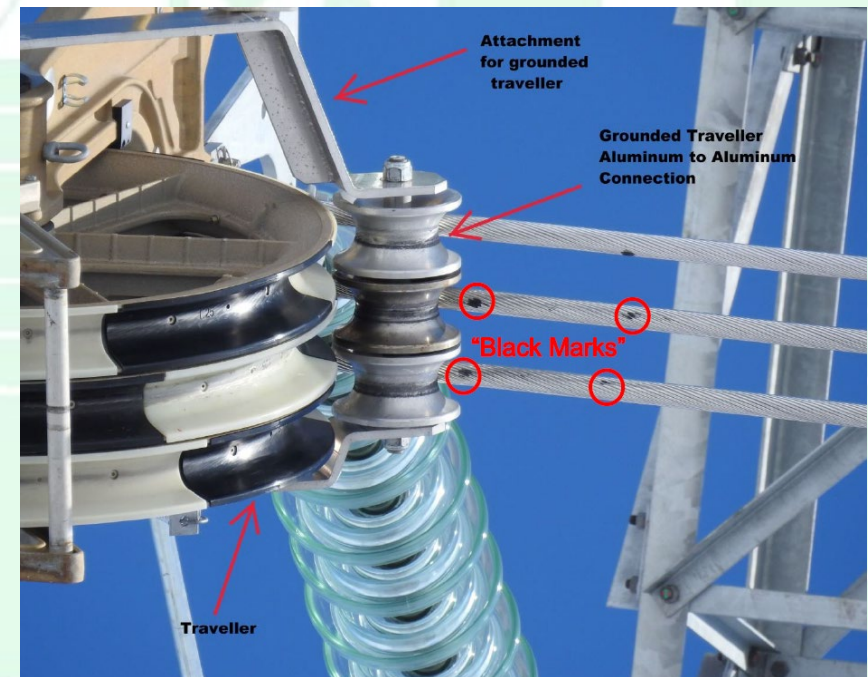
- After identifying a possible cause (local frictional heating), Manitoba Hydro has reviewed the installation procedure and construction records.
- Multiple spans were identified as violating the maximum of 72 hours requirement between sagging and clipping/installation of spacer-damper.
- The ground traveler was also identified as contributing to the conductor damage.
- The documented delays during stringing allowed the conductors to sit on the ground traveler for a long period is one of the major causes of conductor damage.

- A root cause analysis of the visibly damaged on outer strands of ACSR conductor identified extended undesirable contact between the conductor and Ground Traveler as major cause of the damage.
- The stringing procedure including the ground traveler application has been revised at Manitoba Hydro to minimize the possible conductor damage in future project.
- Manitoba Hydro's experience has been also shared within CIGRe and IEEE committee for consideration in future updates to their standards and technical brochures.

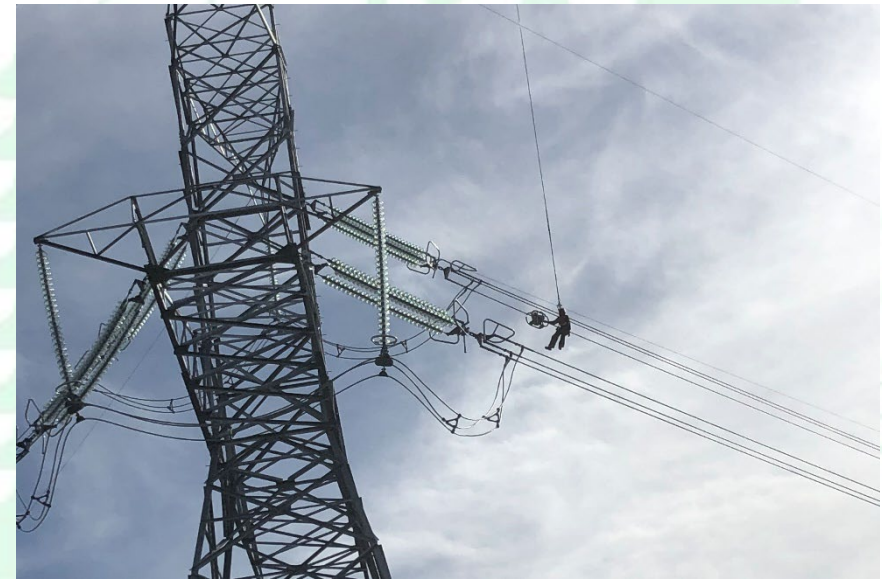
- To confirm the severity of damage on phase conductor, both non-destructive robotic tool and mobile X-ray were used.
- The non-destructive robotic tool was used to inspect the steel core.
- Mobile X-ray was used to examine all aluminum layers near the suspension clamp to confirm the condition of the aluminum strands.

Damaged Component	Severity of Damage	Mitigation Method
Wire / Individual Strand	Up to 10% of strand depth; "intact"	Smooth or polish strand
	10% - 50% of strand depth; "damaged"	Armor/repair rods required to restore conductor strength; refer to criteria for damaged conductor (below)
	>50% of strand depth; "broken"	Armor/repair rods required to restore conductor strength; refer to criteria for damaged conductor (below)
Conductor	≤5 damaged/broken strands on outer layer	Armor/repair rods required to restore conductor strength
	>5 damaged/broken outer aluminum strands on outer layer, or any damage to inner layers	Full tension splice required to restore full conductor strength

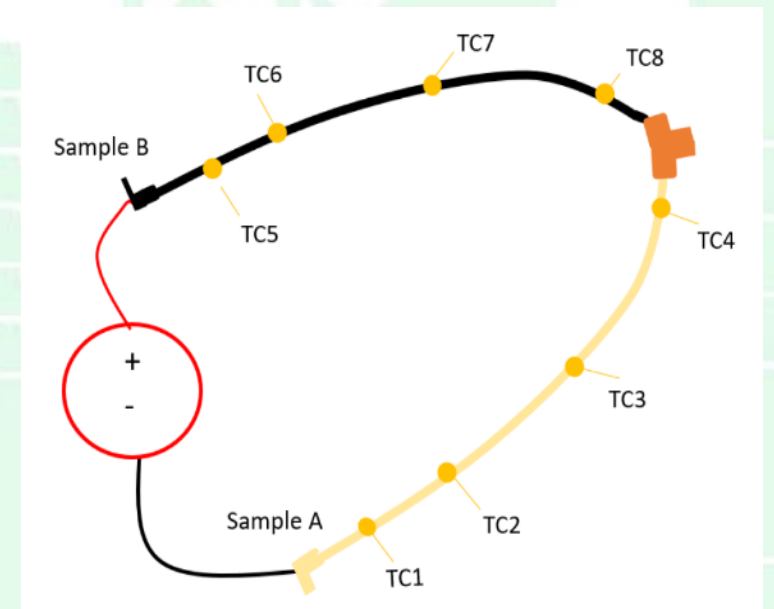
- In addition to mechanical strength loss, a degradation in electrical/thermal performance was also a concern and was investigated in a 3rd party lab.
- The expected operating temperature for this conductor under test condition should be 94°C; Some damage areas resulted in localized heating that exceeded the design temperature and may cause annealing of the conductor. (maximum temperature is 103.2°C)
