Live Work Maintenance on Legacy Double Circuit 144kV H Frame Structures

Vic Barr, Ryan Maltais (Canada)

Abstract 482

2022 CIGRE Session - Calgary – November 1st, 2022

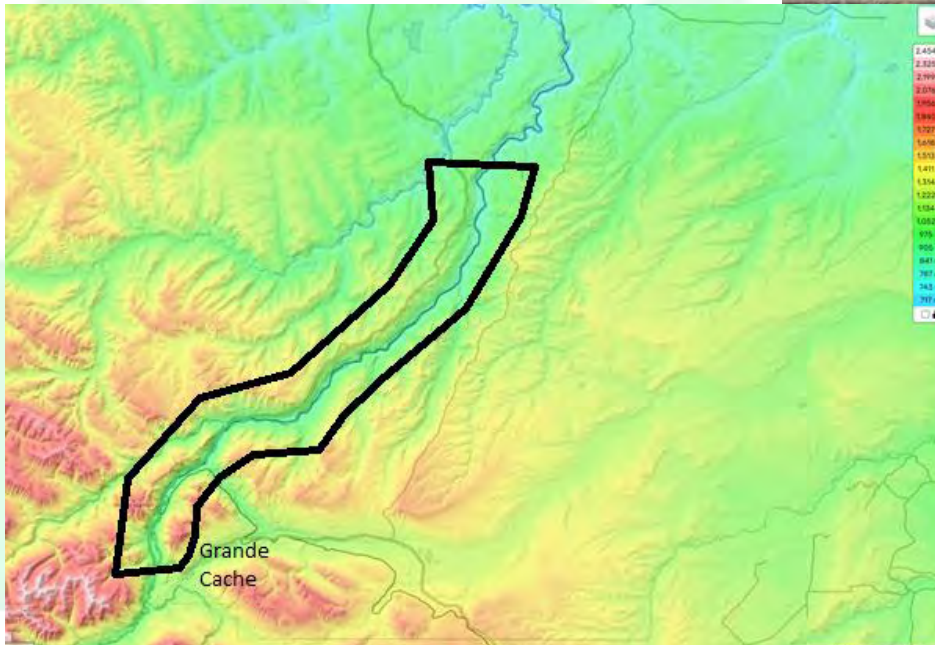
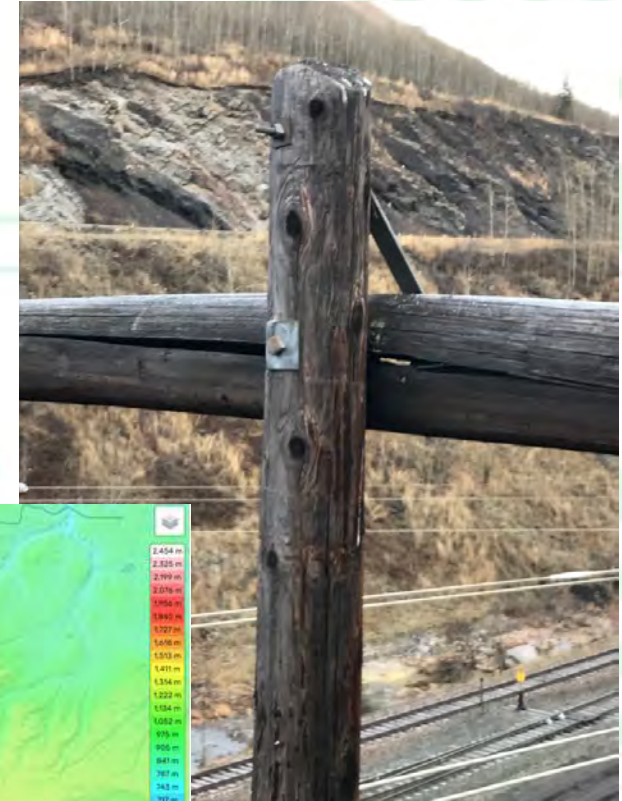
1. 7L80/7L20 Line

1. 1968-1972 builds, D/C for ~6km
2. Topography
3. Wooden cross arms

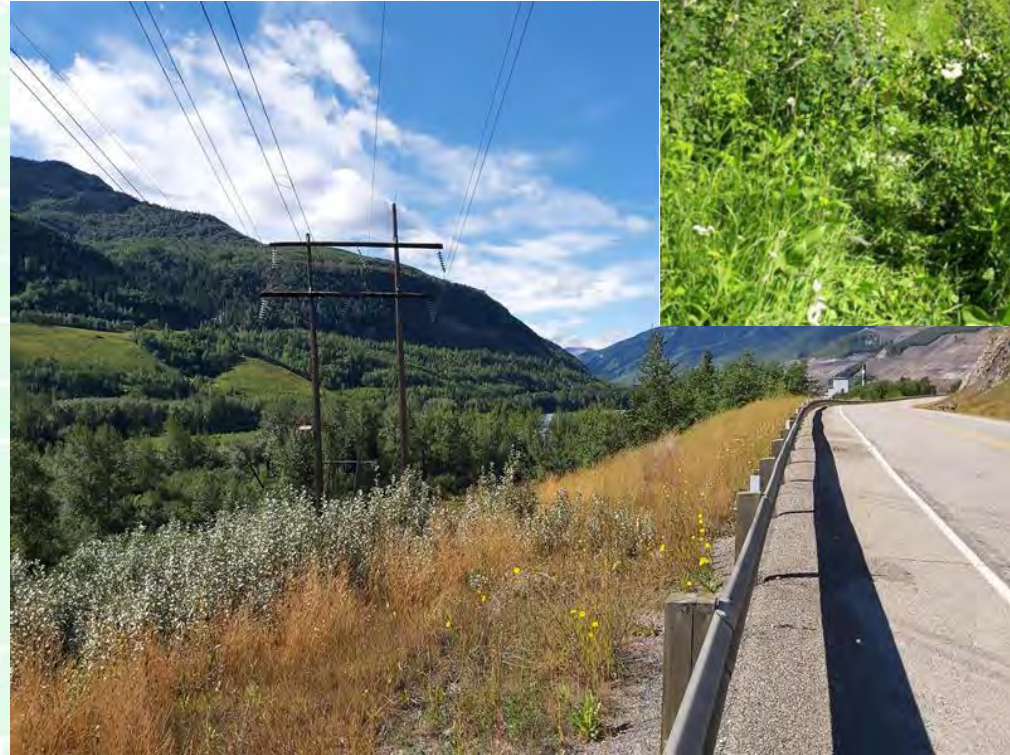
1. ROW width and access
2. Legacy construction standards

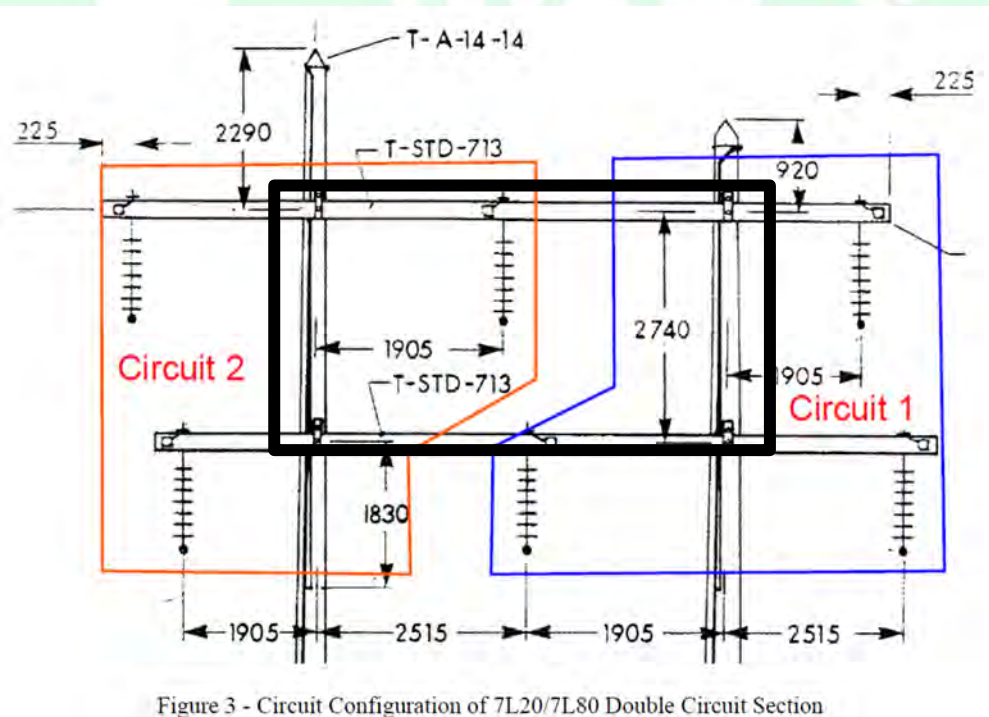
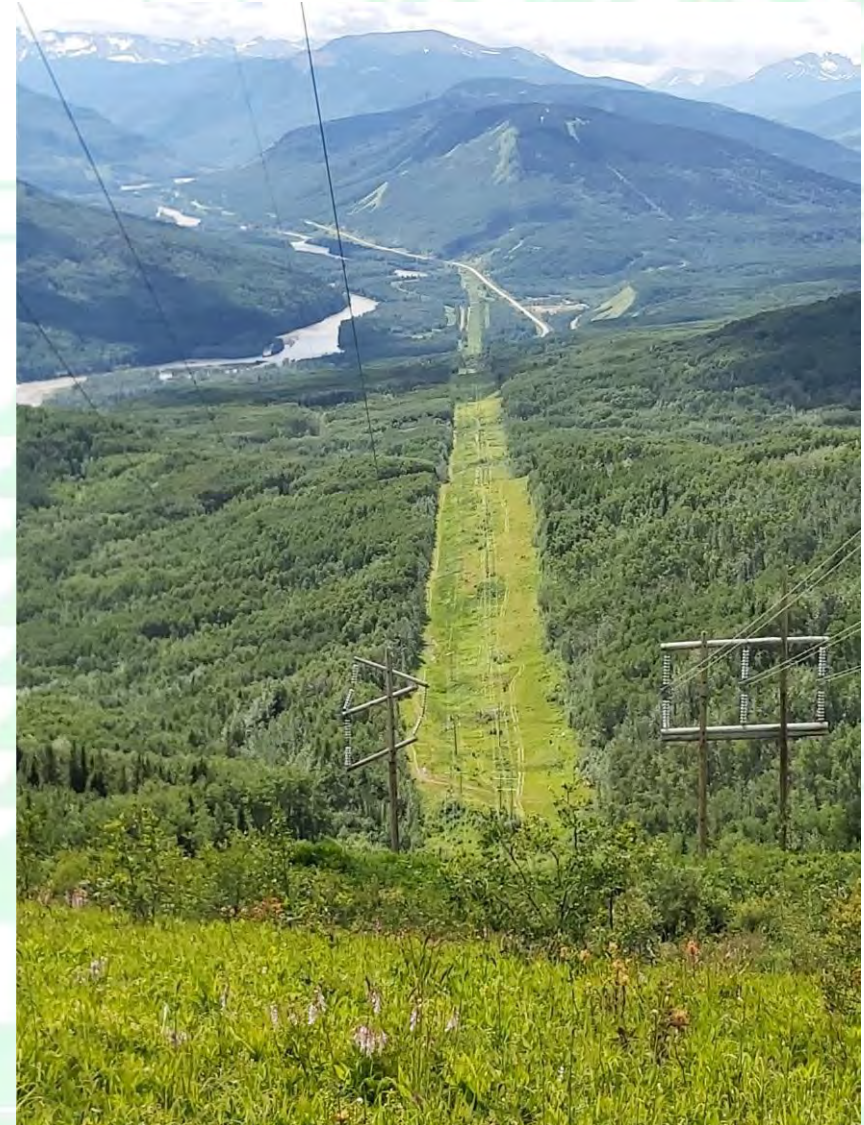
1. ROW width and access
2. Legacy construction standards
