Analysis of Directional Protection on distribution feeders for DER interconnection and its performance during Multi-Fault Events

Marco Ciofani, Iraj Rahimi, Harjinder Sidhu
AltaLink, Canada

Paper Number: 498
Session Number: 8
Date: November 1, 2022

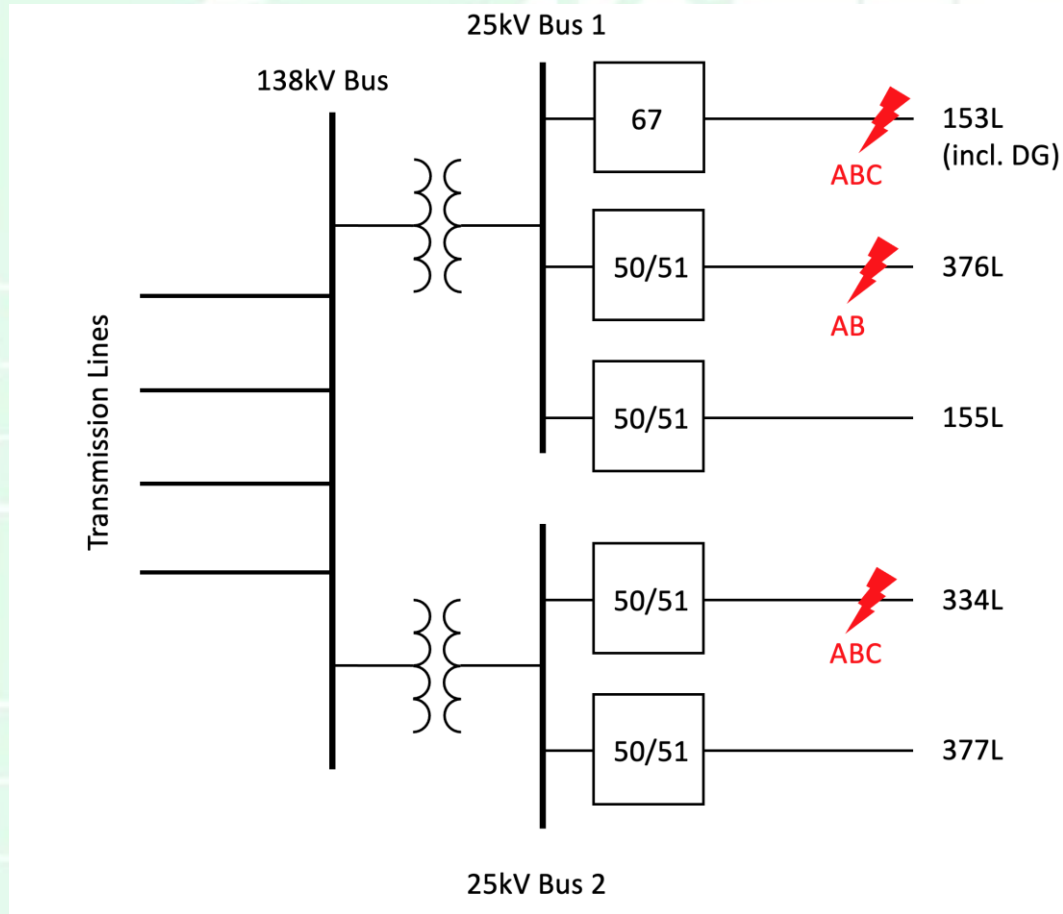
- Feeders are overhead lines and include multi-circuited structures
- Lightning caused faults to occur simultaneously on three different feeders
- 376L and 334L tripped as expected
- 153L failed to trip
- 138/25kV transformer backed up the feeder protection and tripped, causing sustained interruption to three feeders

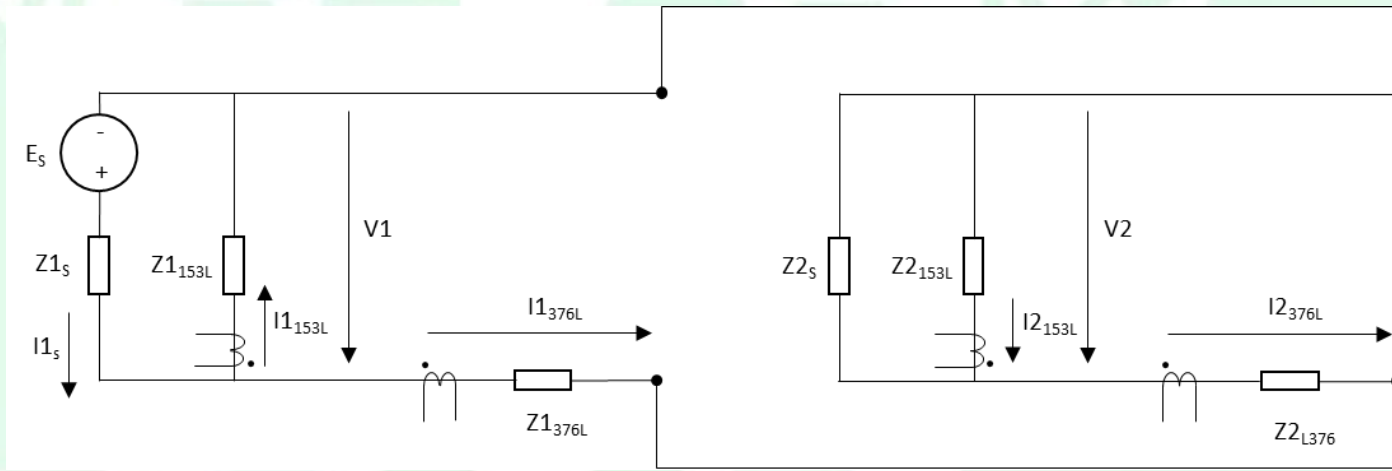
Sequence Network

$$Z_2 = \left| \frac{\bar{V}_2}{-\bar{I}_2} \right| = \left| \frac{-\bar{I}_{2153L} * \bar{Z}_{2153L}}{-\bar{I}_{2153L}} \right| = \bar{Z}_{2153L}$$

- Z2 for 153L relay is equal to the negative sequence impedance of the section of line between the relay and the balanced fault on 153L
- The fault occurred approximately halfway down the line, therefore Z2 was close to the Z2F threshold while the unbalanced fault on 376L fault was present

- Increase Z2F threshold to increase the dependability
 - Potential loss in security, more likely to trip for external faults
 - Likely not a good trade-off
- Communication between relays and logic to interpret multi-feeder fault conditions
 - Additional wiring, logic, and complexity
