Web Applications for Transmission System Asset Health Monitoring

Sunil Agarwal, P.K Srivastava, Sunil Kumar, Manoj Kumar, Abhishek Bhardwaj, Vikas Bishnoi
Power Grid Corporation of India Limited
India

SUMMARY

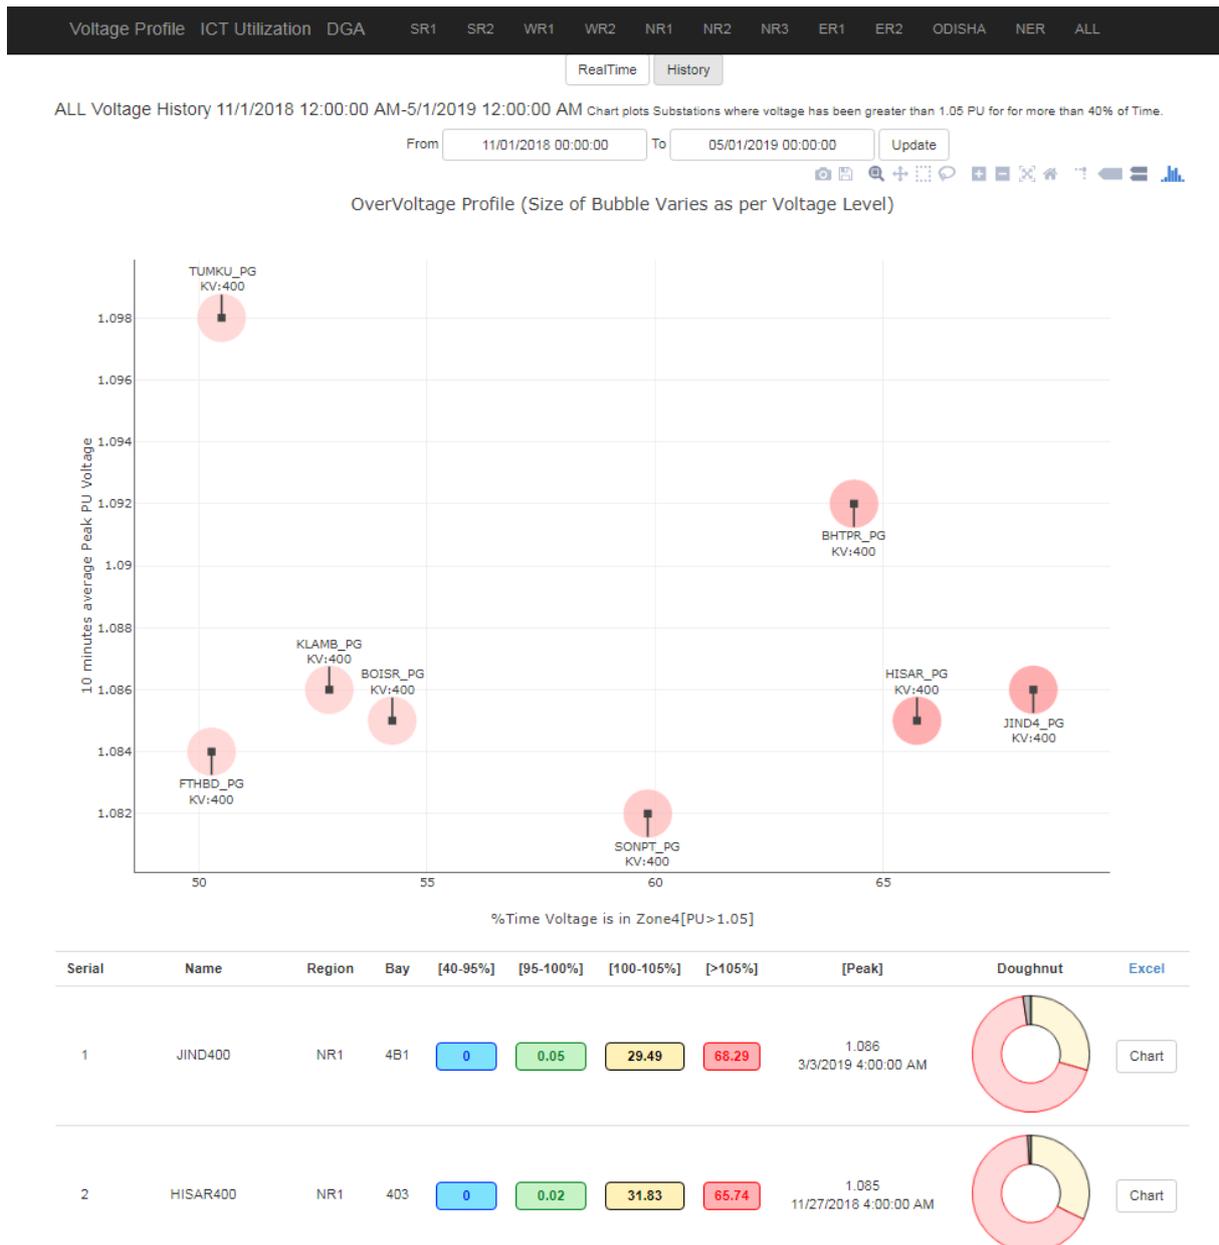
Figure-1 Substation Voltage Dashboard for past 6 months (1st November 2018-1st May 2019)

Per Unit (PU) value of Substation Voltages have been categorized into four zones such that $PU < 0.95$ lies in Zone1, $0.95 < PU < 1$ in Zone2, $1 < PU < 1.05$ in Zone3 and $PU > 1.05$ in Zone4 respectively. Figure1 shows Voltage Profile history dashboard past 6 months (1st November 2018-1st May 2019) depicting percentage of time the voltage lies in Zone4 verses 10 minutes Average Voltage Peak for substations having $PU > 1.05$ for more than 50% of time.

Figure 1 shows that for Jind400(JIND4_PG), Hisar400 (HISAR_PG), Bhatpara400 (BHTPR_PG) substations, voltages lie in Zone4(>1.05PU) for more than 60% of time in past 6 months, and for Tumkur400 (TUMKU_PG), 10 minutes average Peak has been observed above 1.098PU. These results state that the reactive compensation at these locations needs to be reviewed in order to maintain the voltage within permissible limits.

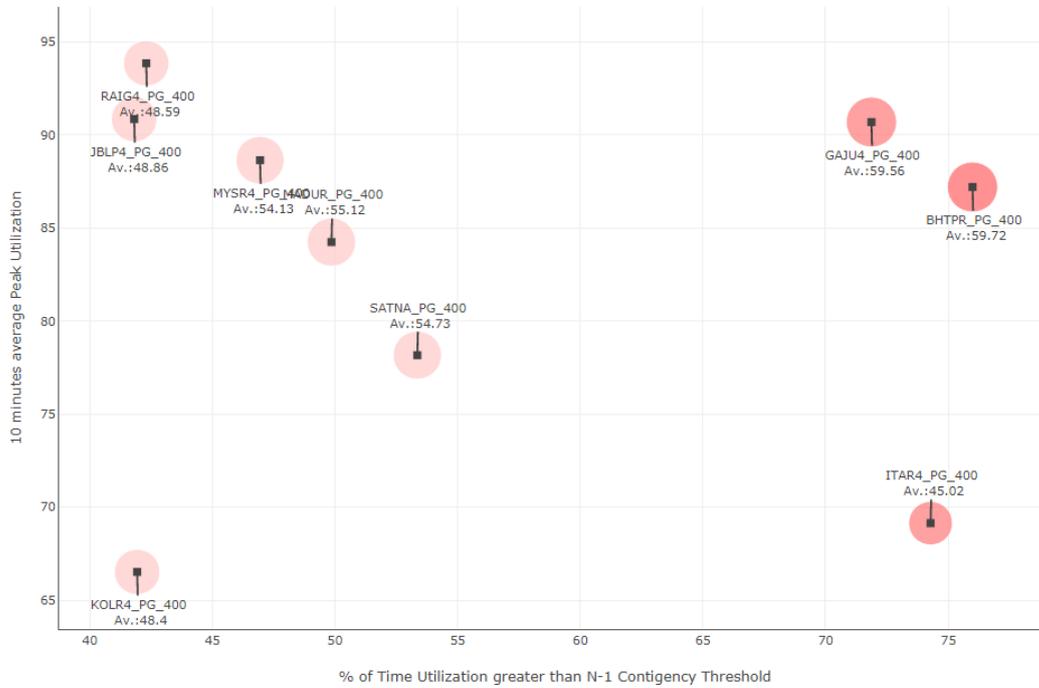
This application helps to determine the sufficiency of redundancy to withstand transformer failure at a substation. Figure 2a shows history dashboard for N-1 Contingency Analysis of Transformer Units where Peak Utilization is plotted against percentage time Transformer Units at a substation violates N-1 contingency criteria. Figure 2b represents transformer loading profile of Gajuwaka substation for past 6 months (1st November 2018-1st May 2019).

Transformer Loading Profile (Size of Bubble Varies with Average Monthly Utilization)

BHTPR_PG_400 Average Utilization:59.72% which is greater than threshold of 50% for 75.99% of time. Peak 87.21% at 4/23/2019 11:50:00 PM.

As shown in Figure 2a, Transformers located at Gajuwaka (GAJU_PG_400), Bhatpara (BHTPR_PG_400) and Itarsi (ITAR4_PG_400) have 2 units each and have violated N-1 contingency threshold for more than 70% of time. Bhatpara and Gajuwaka have 10 minutes

average peak utilization of greater than 85% of their transformation capacity in past 6 months. These results state that transformer capacity at these locations needs to be augmented.

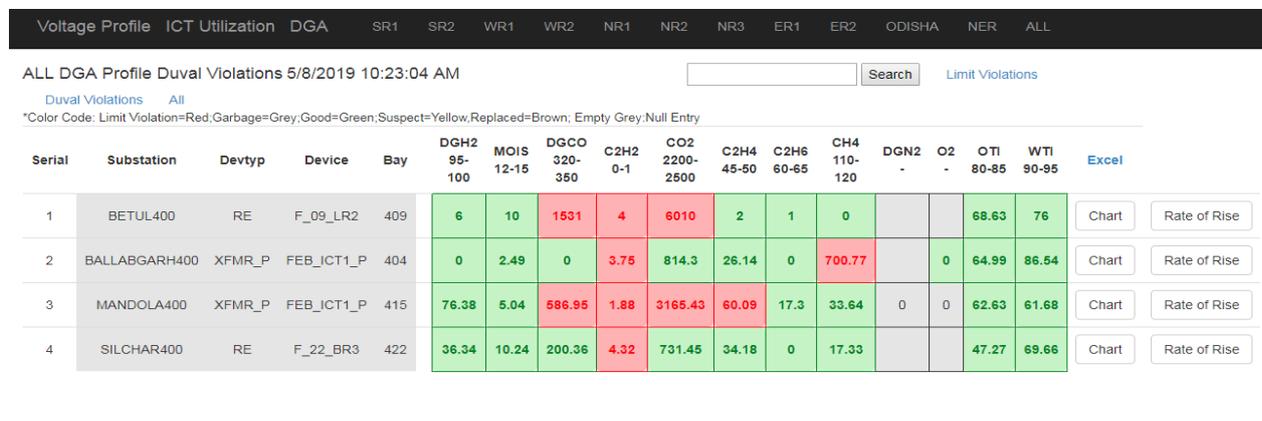
Figure3a: DGA Duval violations present in the system on 8th May 2019 10:23 AM

Dissolved gas analysis of transformer/reactor gives an indicator of incipient fault in the equipment. Dissolved Gas Analysis application analyses dissolved gases as per C57.139-2015 IEEE standard. When dashboard is accessed by operator, DGA analysis based on Duval triangle and IEEE limit violations are checked on dissolved gases real time values, and current limit/duval condition violations are alarmed (Figure 3a).

At Mandola substation violation in CO, C2H2, CO2 & C2H4 have been observed (Figure 3a). Duval triangle^[1] plot of weekly history values of past 6 months for Mandola Transformer Unit-1 is shown in Figure 3b. White Dots in the duval triangle plot lie in T3 zone which signifies high intensity thermal type of fault. C2H2 is primary gas in high intensity thermal faults^[2], as Figure 3c and 3d represent chart of C2H2 and its rate of rise over past 6 months.

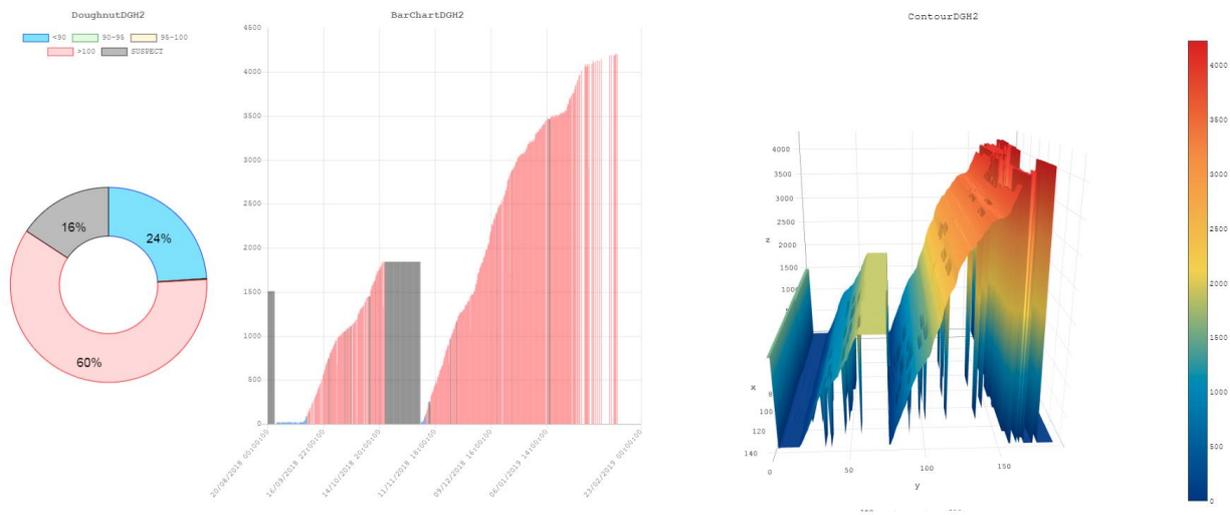
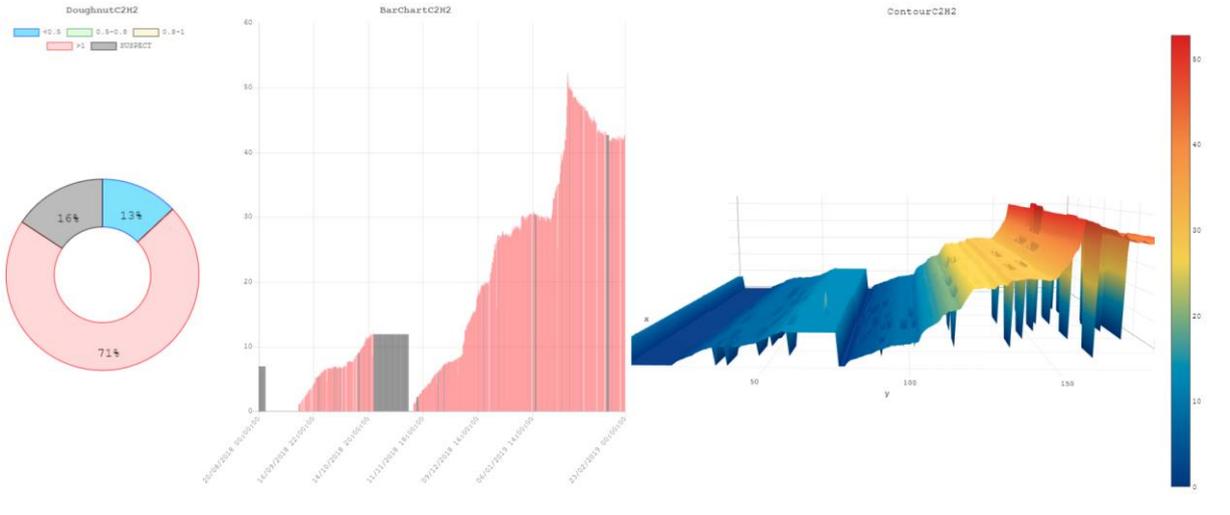
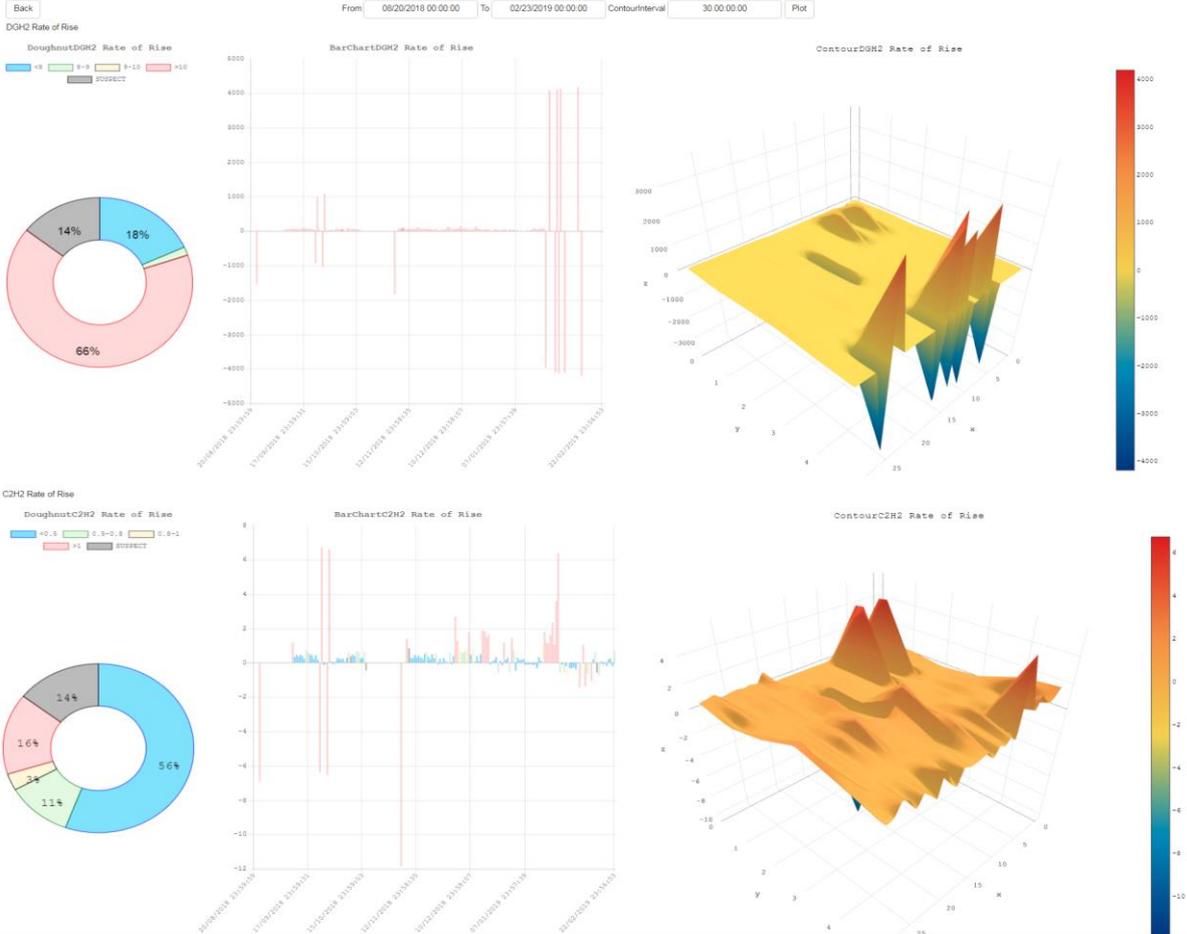
In Tuticorin Bus Reactor rapid increase in Hydrogen and acetylene was observed. In this case only 3 dissolved gases namely are reporting as 3-gas sensor is installed at site, hence online duval triangle analysis is not possible. Hence by monitoring limits and rate of rise violations it was apparent that Hydrogen and acetylene had violated limits beyond IEEE standard as their trends had been increasing continuously (Figure 3e,3f,3g,3h). H2 and C2H2 are referred to as arcing gases. Hydrogen is primary gas generated during low intensity discharges while C2H2 is primarily generated during high intensity arcing faults in 700-1800 °C temperature range [2]. Hence several inspections had been carried out to investigate the possible reasons for arcing.

Figure 3e,3f: Rising Trend of DGH2 & C2H2, Figure 3g,3h: Rate of Rise of DGH2 & C2H2
 (Both trend and rate of rise depict rapid increase in gases for Tuticorin Bus Reactor 1)
 Figure 3i: Core Shield of Y Phase, Figure 3j: Y Phase aluminium cup showing black powder
 generated because of arcing

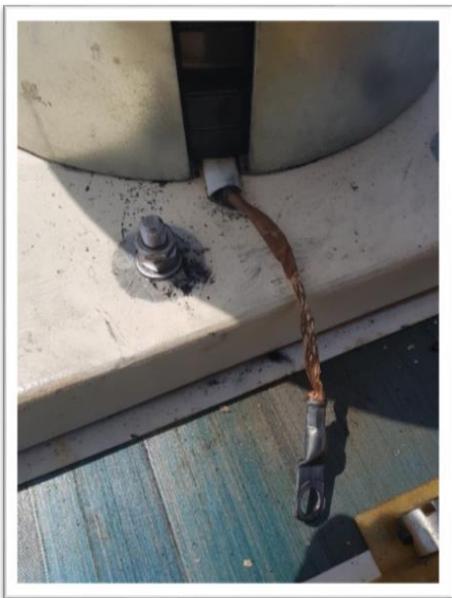
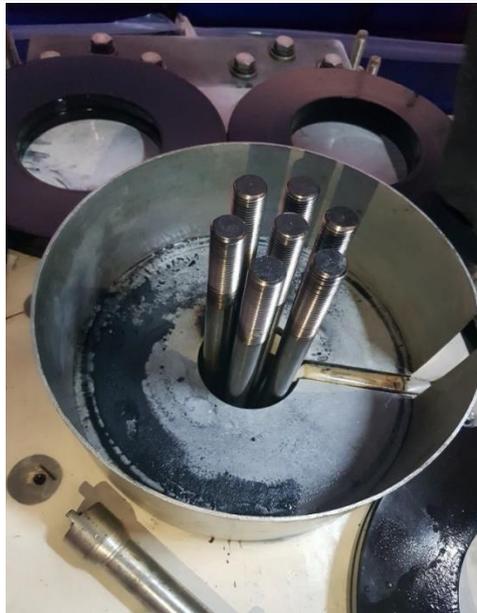
During first two internal inspections on 8th August 2018 and 5th November 2018 all HV bushing corona shield were found loose. HV bushings were replaced after second inspection but still DGA trend was increasing rapidly. Shutdown of the reactor device was availed on 23rd February 2019 and oil draining of reactor had been done. At this time arcing in corona shields of R & Y phase HV RIP Bushings had been found. After opening of the main tank cover of reactor black powder type dust particles were observed in core shield of Y-Phase, top yoke of Y and R phase. After opening of top yoke of the reactor and removing the belly washers it was found that the aluminium cups of both R and Y phase surrounding the belly washers were touching with the tie rods causing hotspot due to vibration. After cleaning of tie rods and balance areas, the top yoke had been reinstalled. The reactor was again charged 24th April 2019 after taking dissolved gases samples which were found within limits.
