## **Monitoring & Condition Assessment of large Rotating Machines using latest Partial Discharge Detection and Analysis Techniques**

**A. El-Rasheed, M. Söller, M. Huzmezan  
Megger Limited, Canada**

### **SUMMARY**

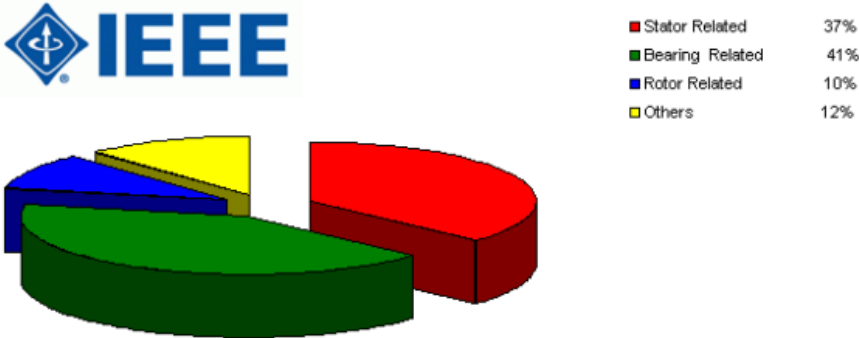
Rotating machines are crucial part of our modern world. These versatile machines can be used for power generation, factory work, and even transportation among many other applications. Therefore, preventative maintenance of these assets is also a crucial job. A common cause of rotating machine faults is the stator winding insulation failure, as shown from research published by IEEE in Figure 1.

Figure 1: IEEE analysis of 3000 machines (1995)

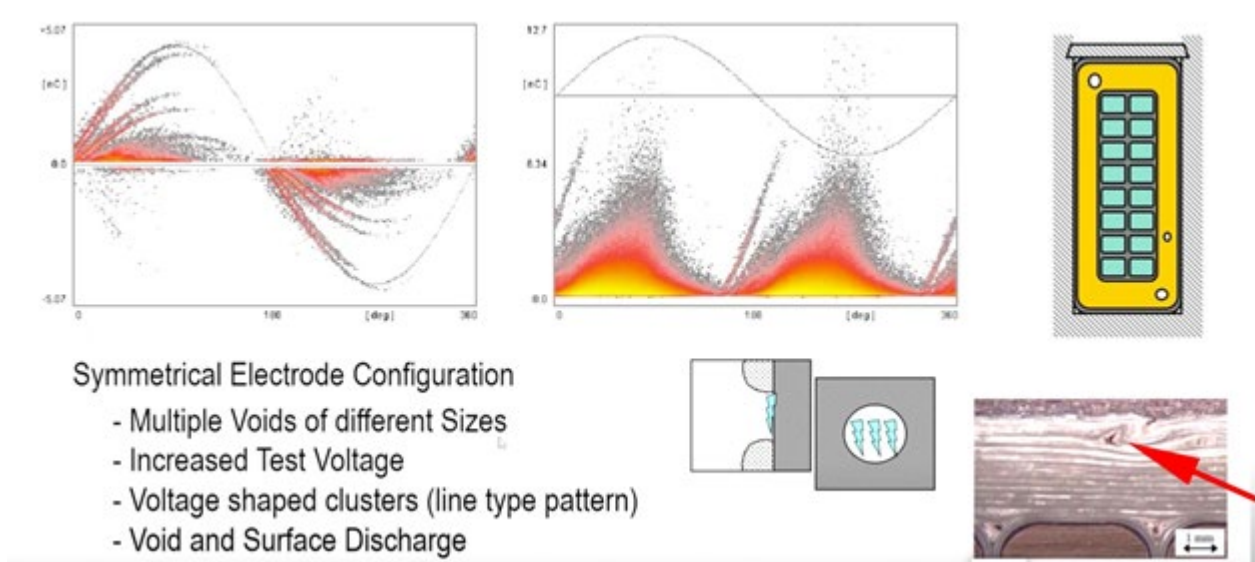
The gas molecules in a typical void, indicated by the red arrow in Figure 6, are ionized by cosmic photons and the free electrons can produce internal discharge pulses due to the electrical field exceeding the breakdown level leading to PD impulses. When these pulses are measured, "fresh" voids on new machines show up in a distinct line pattern. The screen image in Figure 6 shows the captured PD activity, which indicates seven individual voids. Over time, the discharge in the void will create increased carbonisation, which then increases PD activity. This leads to a more distributed pattern over time. The carbonisation provides more free electrons in the voids and this creates the more distributed pattern.

Figure 6: PD pattern from voids in the insulation

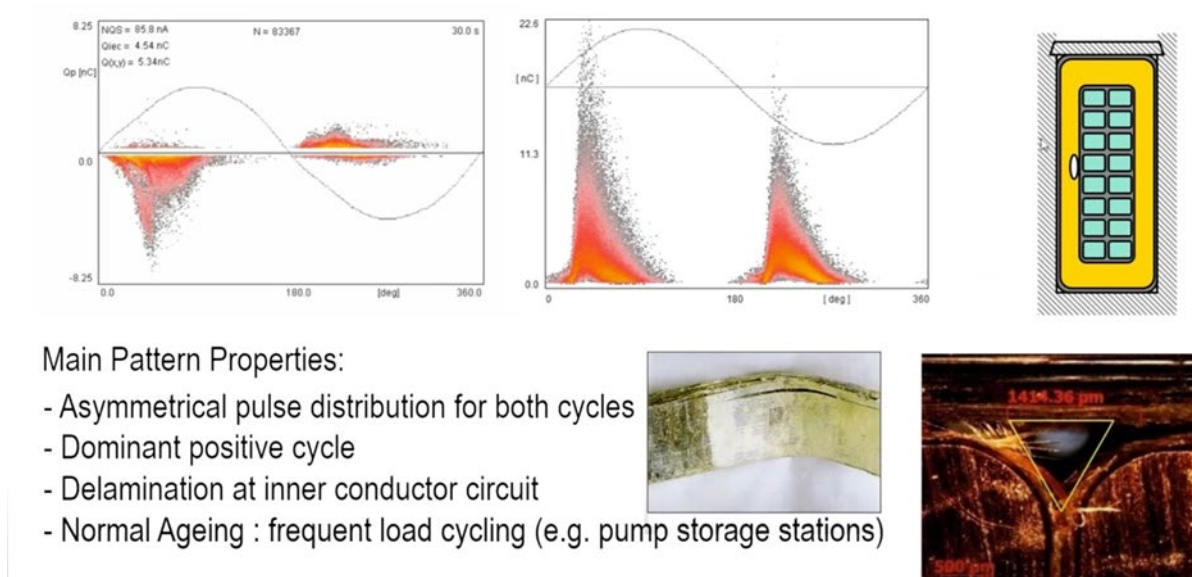
Delamination close to the inner conductor produces an asymmetrical partial discharge pattern, as seen in Figure 7. In bipolar mode (left hand screen image), the PD activity of the first half cycle is shown below the x-axis. While in unipolar mode (right hand screen image) shows activity in the same relative phase position but entirely above the x-axis. This pattern of high PD activity in the positive half cycle and lower activity in the negative half cycle is typical for conductor binding delamination issues.

Figure 7: PD pattern from conductor binding delamination

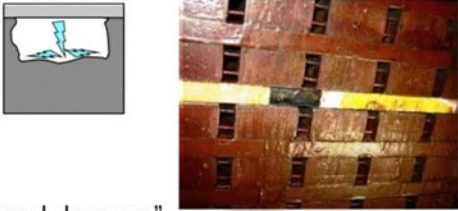
Insulation defects at the outer area cause the reverse PD pattern seen with conductor binding delamination. Figure 8 shows PD activity at its highest in the negative half cycle, while it is less than half the amplitude in the positive half cycle. The bipolar pattern, which is on the right in Figure 8, shows the PD in the negative half cycle starts close to zero and crosses the applied voltage forming a triangular shape.

- Predominantly in the negative Half Cycle
- Often typical triangular Pattern
- Strongly Load Dependent due to Magnetic Forces
- Delamination at the slot corona prevention layer
- Consequent high Ozone (O3) generation causing "collateral damage"

Figure 8: PD pattern for slot discharge at machine bars

To make this type of determination, it is critical that the phase relationship between the applied voltage and the pattern display is correct. Therefore, the synchronisation signal from the coupler is as important as the PD signal. This type of PD activity produces ozone from the epoxy-mica insulation. Ozone causes a lot of damage and the longer this PD activity continues the worse it will get.

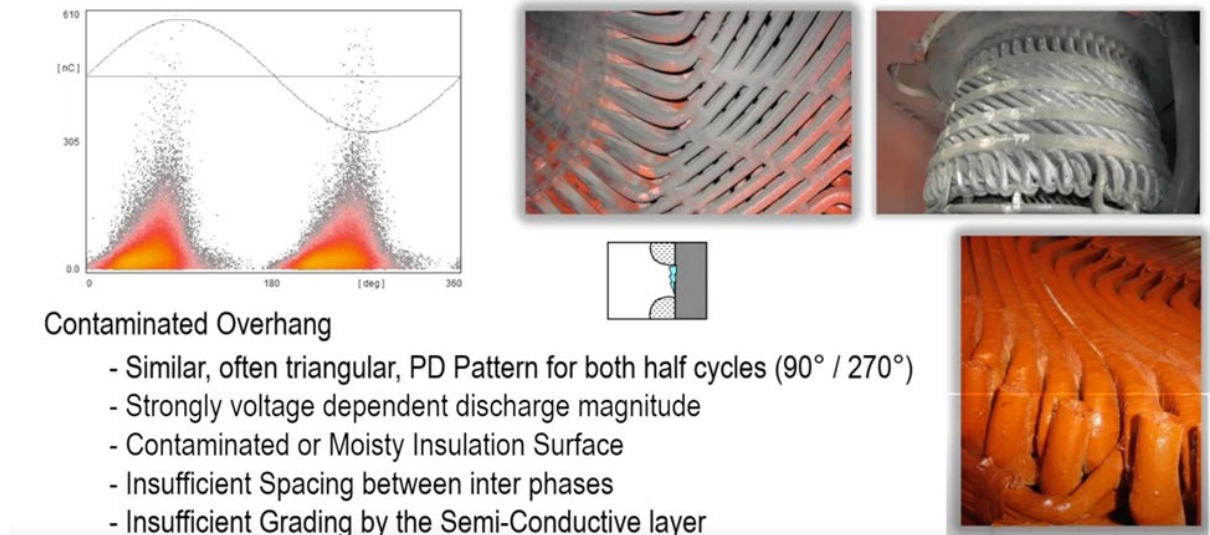
The white powder seen in the photographs of Figure 10 are a result of ozone action, which leads to surface discharge. Dust and other contaminants can also cause end winding surface discharge. The PD pattern here reveals that the maximum PD activity coincides with the maximum applied voltage. Surface discharge is strongly dependent on applied voltage, which creates the observed pattern. Also, proximity of surfaces because of insufficient spacing can cause surface discharge.

Figure 10: PD pattern for end winding surface discharge

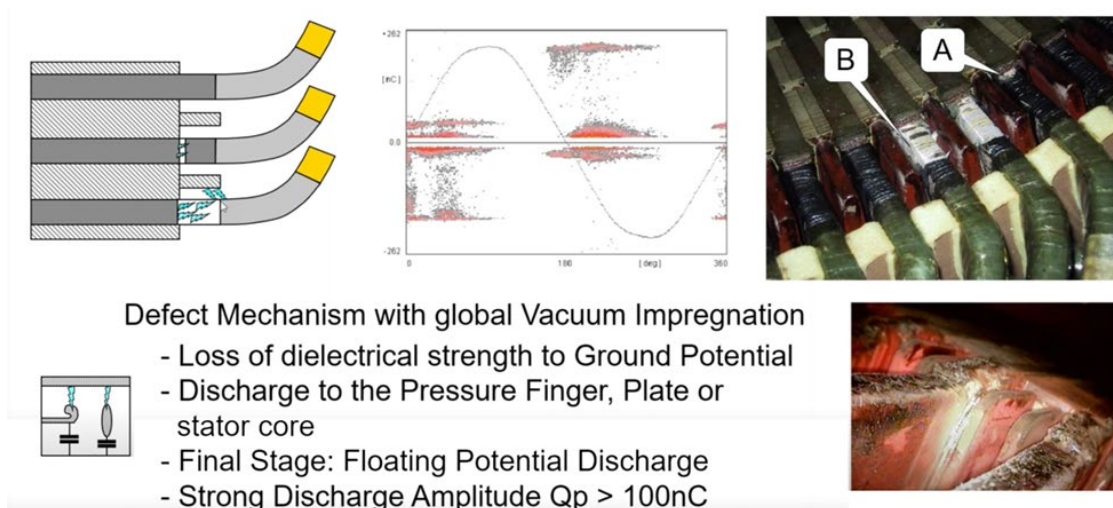
A few months later, the situation with the slot-exit discharge had deteriorated to the point shown in Figure 12. The PD pattern is different because of floating potentials. The pattern is flatter with a much greater amplitude than at the early stage.

Figure 12: PD pattern for slot-exit discharge at final stage

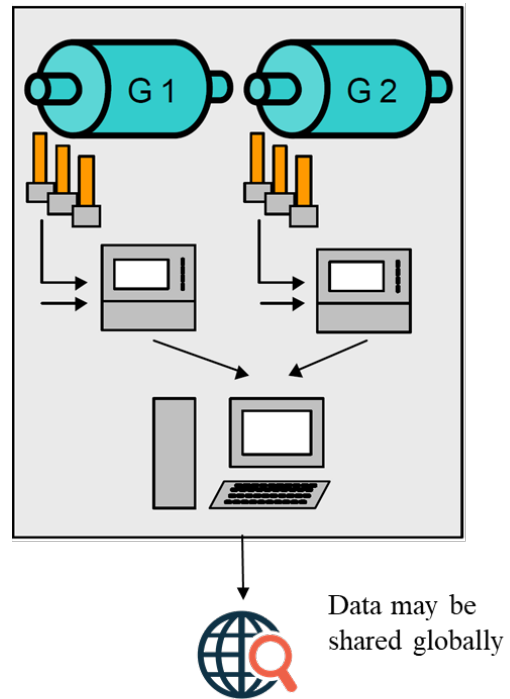
As seen in Figure 14, a utility can create a monitoring system with PD instruments collecting signals and feeding a central server where further analysis of trends can be done. This structure is scalable, allowing use on all the high value rotating machines at a site. Furthermore, monitoring of various sites can be done when linking the local servers to a central server. Valuable live data is viewed and up to the minute health assessments can be automatically done.

Figure 14: Monitoring system

An online PD monitoring system is the effective method for preventative maintenance. As demonstrated in the case study, sensors are installed on the rotating machines and their signals provided to the PD instruments. A system is created when multiple assets are monitored, and the PD measurements transmitted to a central server. There are software suites available that can perform analysis and automatically alert whenever conditions deteriorate beyond a set point.
