Case Study Live Work Maintenance on Legacy Double Circuit 144kV H Frame Structures

V. BARR, S. JIANG, D. VACHON, R. MALTAIS, K. OBERLE, S. NEELAWALA
ATCO Electric
Canada

Transmission line maintenance on legacy transmission structure has become more challenging, especially where the live work is required. Concerns were raised when ATCO Electric planned to replace deteriorated wooden crossarms on a portion of 6 km of D/C (Double Circuit) 144kV line 7L20/7L80 c/w 25kV distribution underbuilt. This portion of D/C line was installed in 1971 on legacy wooden H-Frame structures. This legacy structure is not in compliance with current ATCO standard design in terms of inter circuit clearance requirements and cause potential maintenance limitations. As each crossarm carries phase conductor(s) from different circuits, it is ideal to de-energize both transmission circuits to replace the cross arms. As 7L20 and 7L80 are the only two transmission lines connecting power generation and community to rest of the system, simultaneous de-energization of lines is not possible to perform maintenance. Live work maintenance on this D/C line therefore becomes the only acceptable approach in this case.

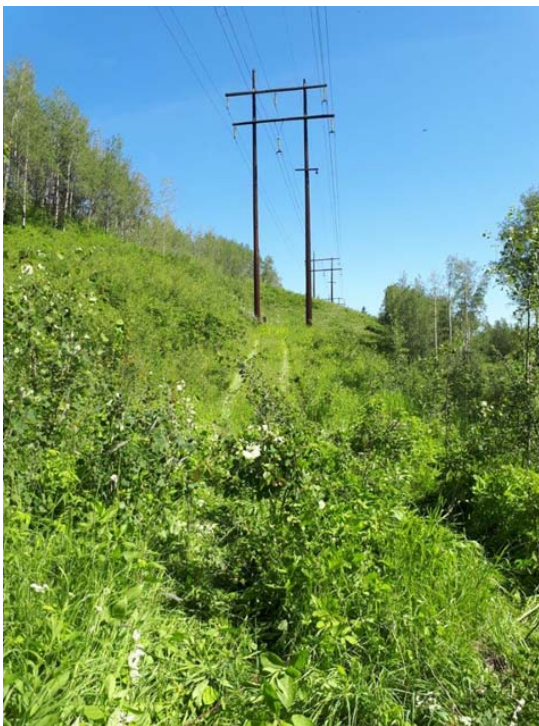
7L20 and 7L80 are two 144kV legacy lines built to connect Grand Cache area to the rest of the transmission system. Both lines were built in hilly terrain. 7L80 was built in 1968 with Partridge conductor. 7L20 was added to the system in 1972 and built with bundle Ibis. Approximately 6 km of the parallel section of the lines was built with double circuit H-frame structures with distribution underbuilt due to terrain and ROW constraints.

Figure 1: 7L20/7L80 D/C Section ROW

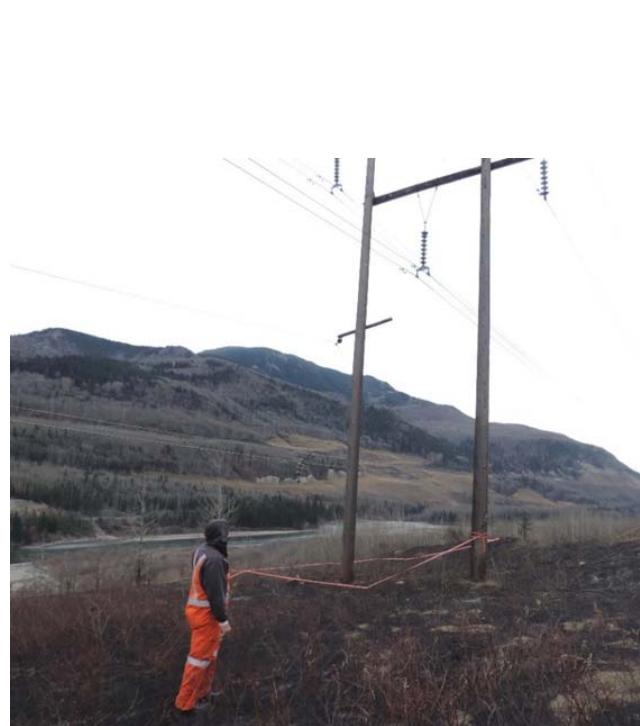
Figure 2: Crossarm Failure Causing Grass Fire

Crossarm failures and inter-circuit clearance issues of double circuit section became a reliability issue of these lines. Crossarm failures caused some environmental impacts too. Though ATCO had taken some temporary measures for inter-circuit clearance issues of the double circuit section over the years, the load transfer in emergency situations continue to cause outages in the energized line. Therefore, ATCO planned to replace the deteriorated wooden crossarms in these lines and to give the priority to double circuit section.

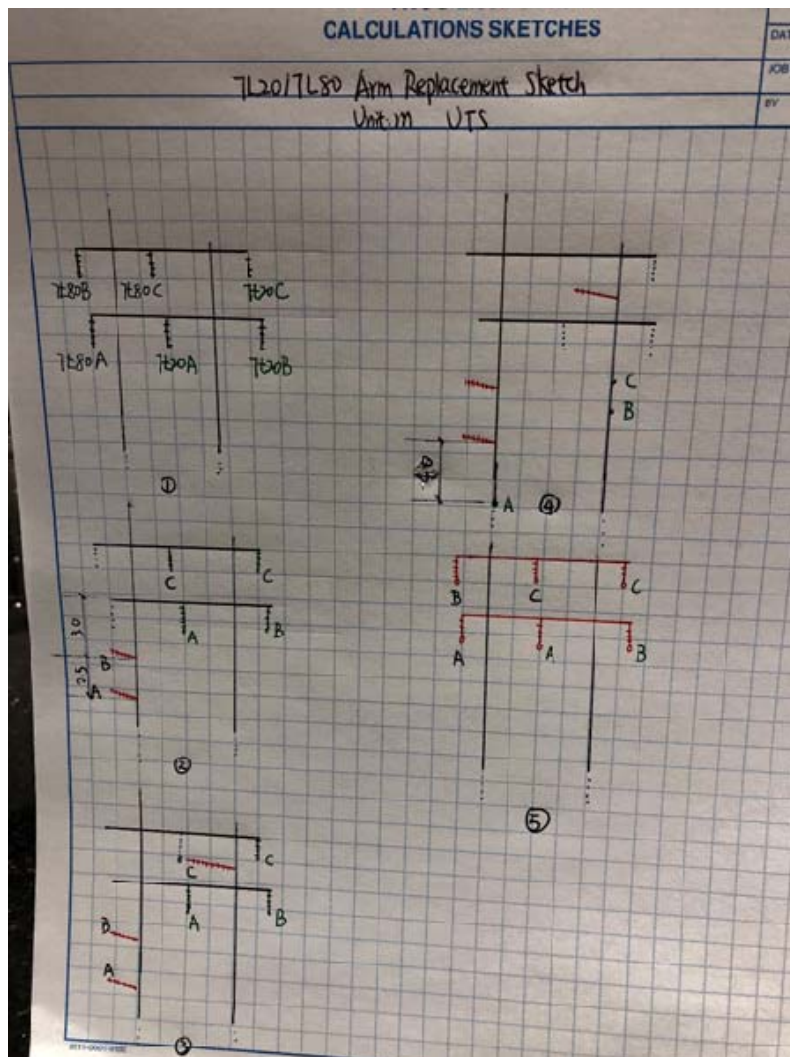
The following steps provides the high-level work summary of the procedure adopted for the completion of the cross-arm replacement safely and successfully. Figure 5 provides the illustration of the steps.

1. Starting position with both circuits energized
2. Relocate phases A & B from circuit 1 to temporary K-arms located below.
3. Install a temporary K-arm for phase C on circuit 1 and relocate phase C.
4. Remove de-energized circuit 2, Replace appropriate materials
5. Move to final position with both circuits energized

Figure 6 – Work Summary

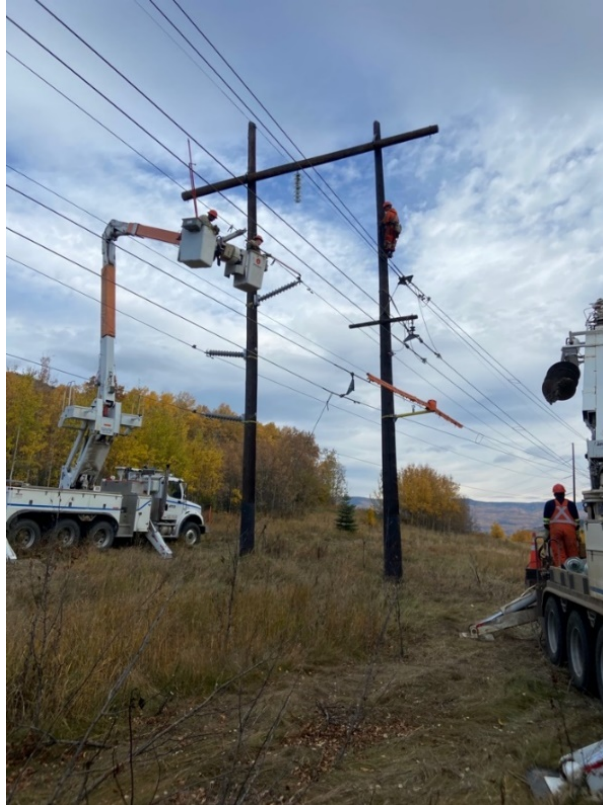
Figure 7 – Work Execution
