Analysis of Directional Protection on distribution feeders for DER interconnection and its performance during Multi-Fault Events

Marco Ciofani, Iraj Rahimi, Harjinder Sidhu
AltaLink Management Ltd.

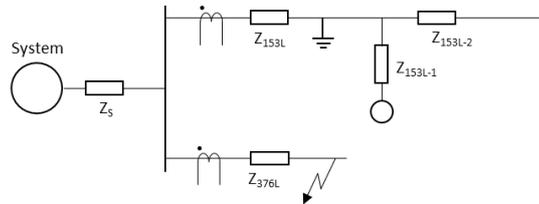
Figure 7 – Equivalent circuit for the event

We focus on the latter portion of the event subsequent to the 334L fault being cleared, as it did not have a major influence on the behavior of the 153L relay. A simplified diagram of the system at this stage is shown in Figure 7. The three phase fault on 153L is considered as a solid grounding point. The sequence network is then drawn assuming boundary conditions for the 376L phase to phase fault as shown in Figure 8. Relay CTs are included for both feeders with polarity indicated.

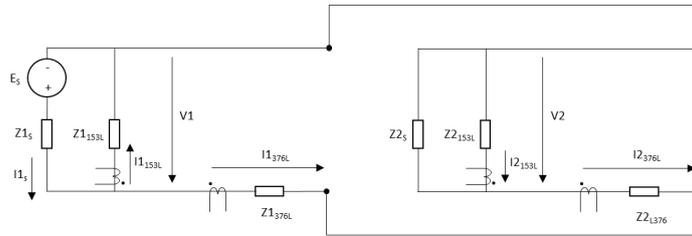
Figure 8 – Sequence network for the event

Using this circuit, the positive and negative sequence voltages and currents that are expected to be seen by the relays during this event are calculated. The following assumptions are used in the circuit calculations:
