Analysis of Directional Protection on distribution feeders for DER interconnection and its performance during Multi-Fault Events

Marco Ciofani, Iraj Rahimi, Harjinder Sidhu
AltaLink, Canada

Paper Number: 498
Session Number: 8
Date: November 1, 2022

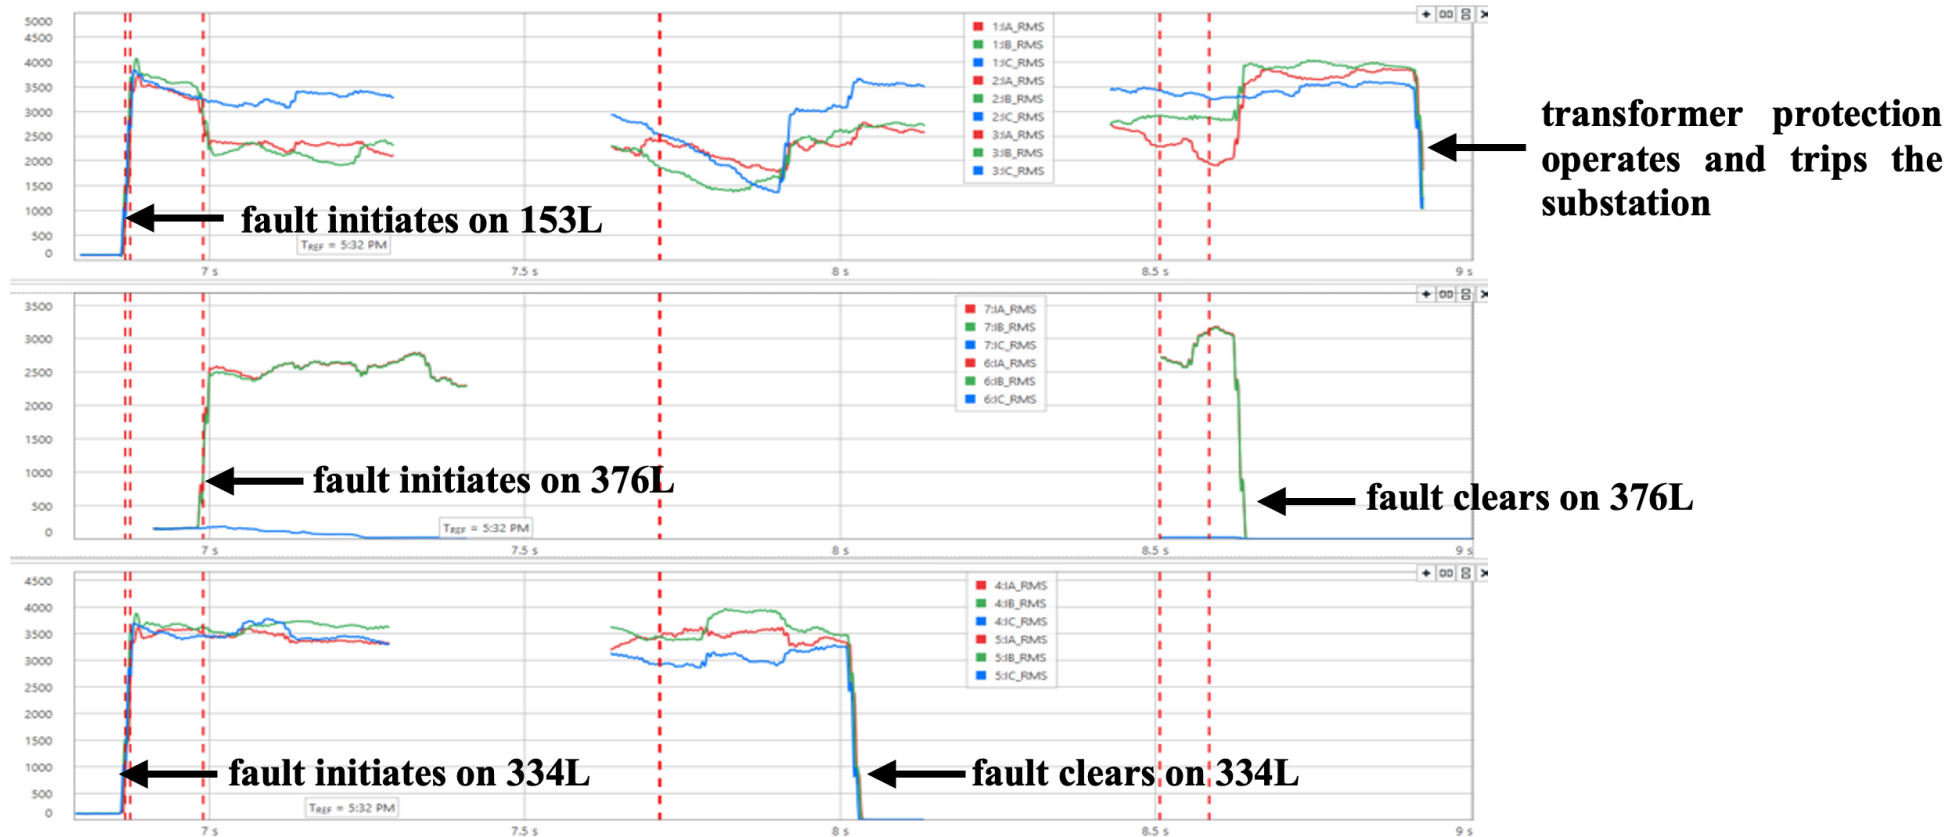
Event Overview

- Feeders are overhead lines and include multi-circuited structures
- Lightning caused faults to occur simultaneously on three different feeders
- 376L and 334L tripped as expected
- 153L failed to trip
- 138/25kV transformer backed up the feeder protection and tripped, causing sustained interruption to three feeders
